Date: November 13, 2024, updated February 14, 2025

Subject: **Arborist Report for the Cobb Community Park Project, Lake County, California**

Attachment A

Tree Inventory

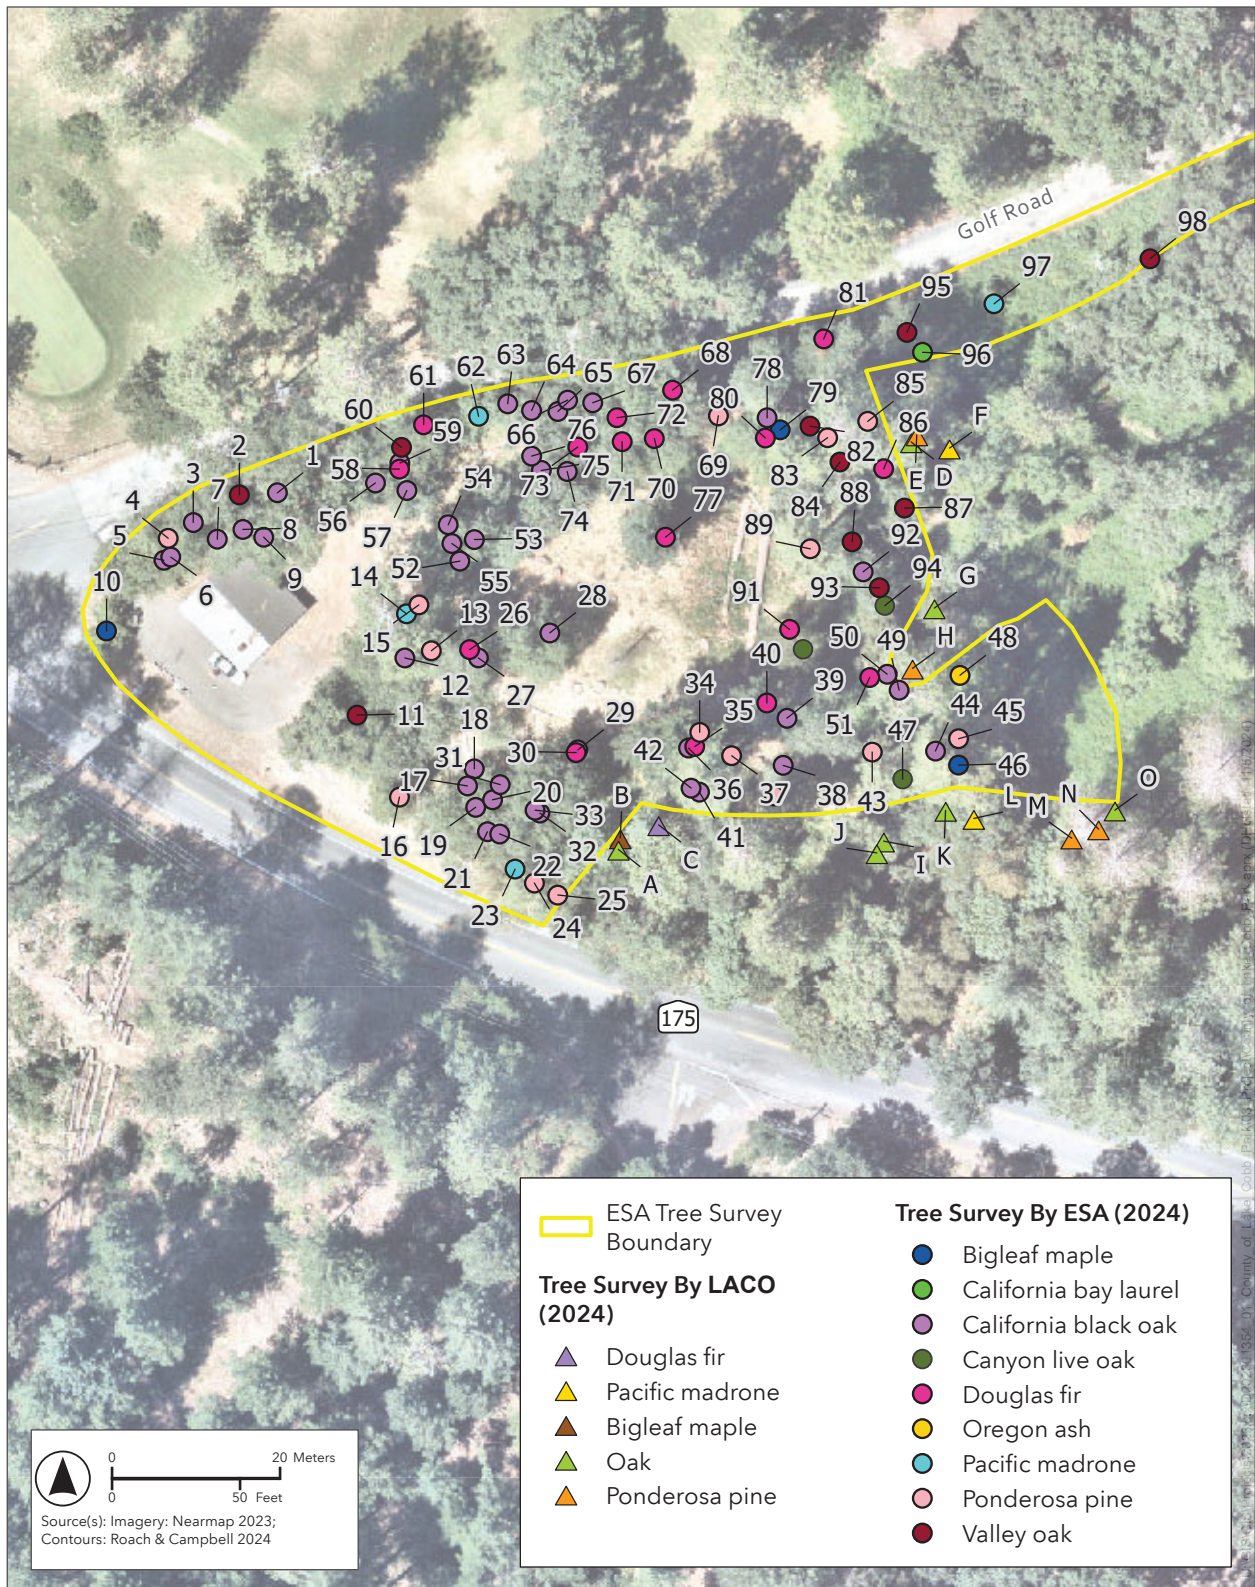
Figure 1A
Tree Inventory
Cobb Community Park
County of Lake

A total of 114 trees were inventoried. An additional 30 trees provided by LACO Associates are also shown on the figure in Attachment A and included in the tables in Attachment B. This tree data was not verified by the ESA arborist.
