ARBORIST REPORT AND TREE PROTECTION PLAN

6720 Leslie Place
Lucerne, CA 95458

August 2023; Updated November 2023

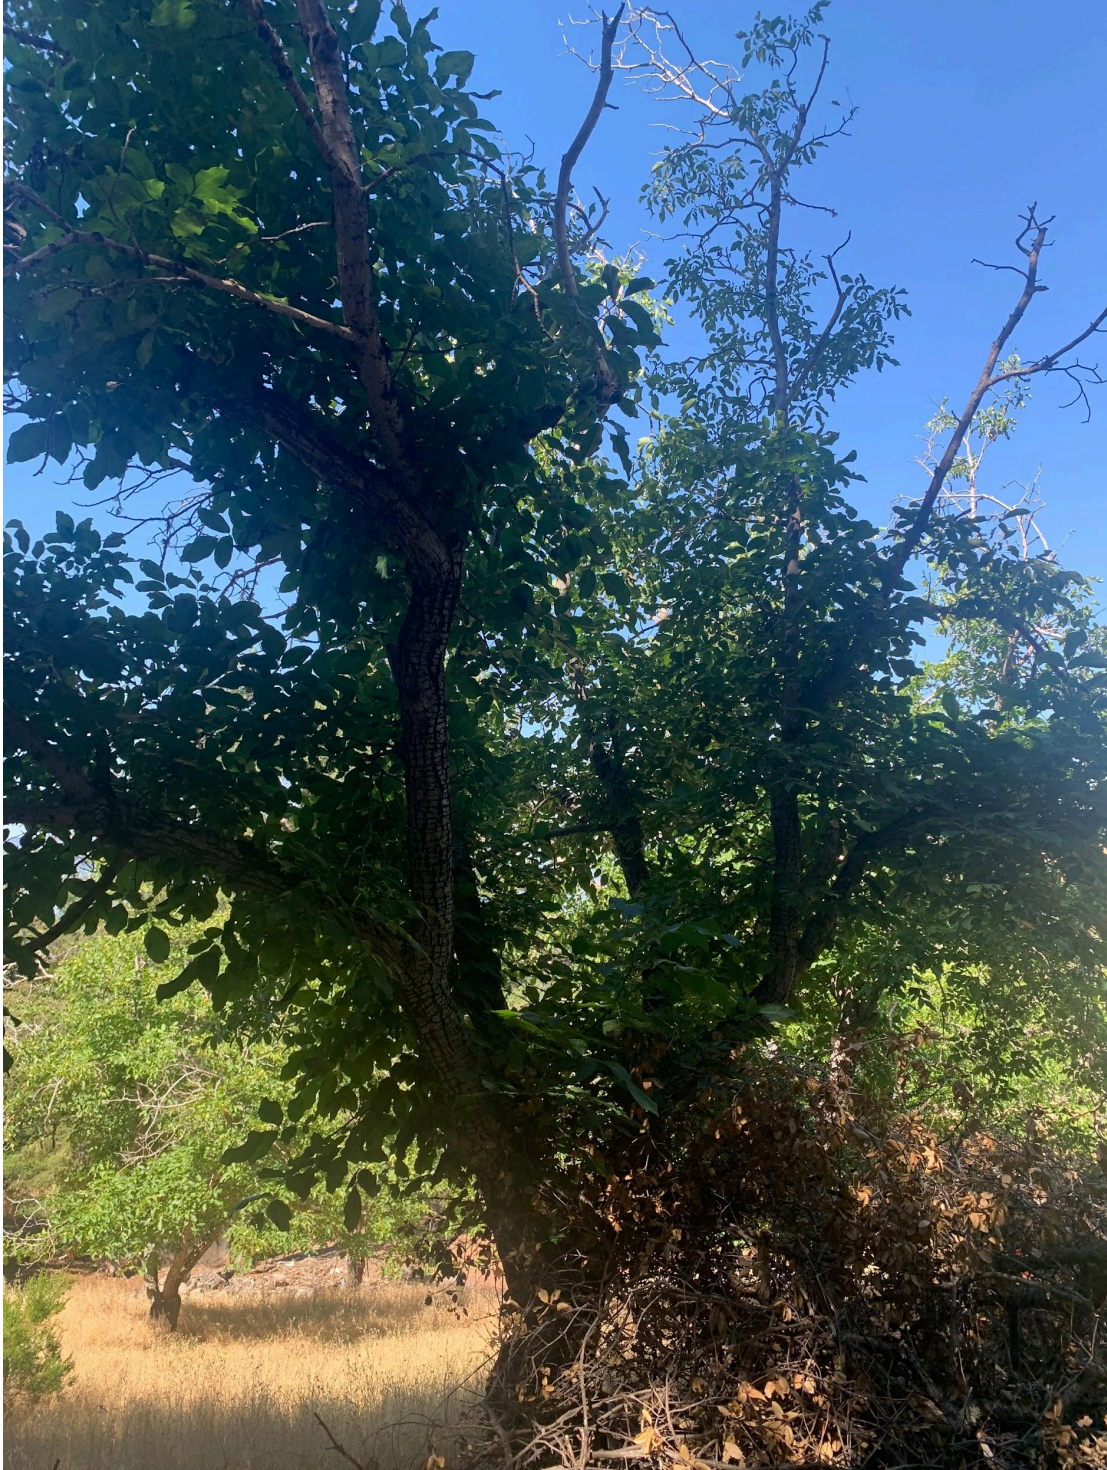
Tree #	DBH (in, sum)	Stems	Common Name	Preservation Priority	Proposed Removal (Y/N)	Notes
1	8,8	2	Black walnut	3	Y	2 stems @ ground level, within road expansion, has small deadwood, and pest hole in canopy.
2	12, 8	2	Interior live oak	2	Y	Decay in 1 stem, one-sided canopy, small deadwood, and within road expansion.
3	6,5,4,4	4	Interior live oak	2	Y	4 stems form above ground level, within road expansion, one sided, and decay in roots.
4	9,9,8,4	4	Interior live oak	2	N	4 stems from above ground level, decay in one trunk, unbalanced canopy, and small deadwood.
5	14	1	Interior live oak	2	Y	within the road expansion, unbalanced canopy, and small deadwood.
6	15	1	Black walnut	2	Y	In the road expansion and small deadwood.
7	16	1	Interior live oak	2	Y	within the road expansion, decay in trunk, lean, and unbalanced canopy.
8	12, 6	2	Interior live oak	3	Y	within the road expansion, decay in the trunk, lean, and unbalanced canopy.

Photo 2. Tree #1, in fair condition, in the road expansion plans. Removal is recommended.

- Trees #1, 2, 3 5-8, 10-15, 17, 32, and 33 are within the limits of or have SRZs that will be impacted by the proposed plan for the road expansion. The trees ranged from good to poor. Removal is recommended.

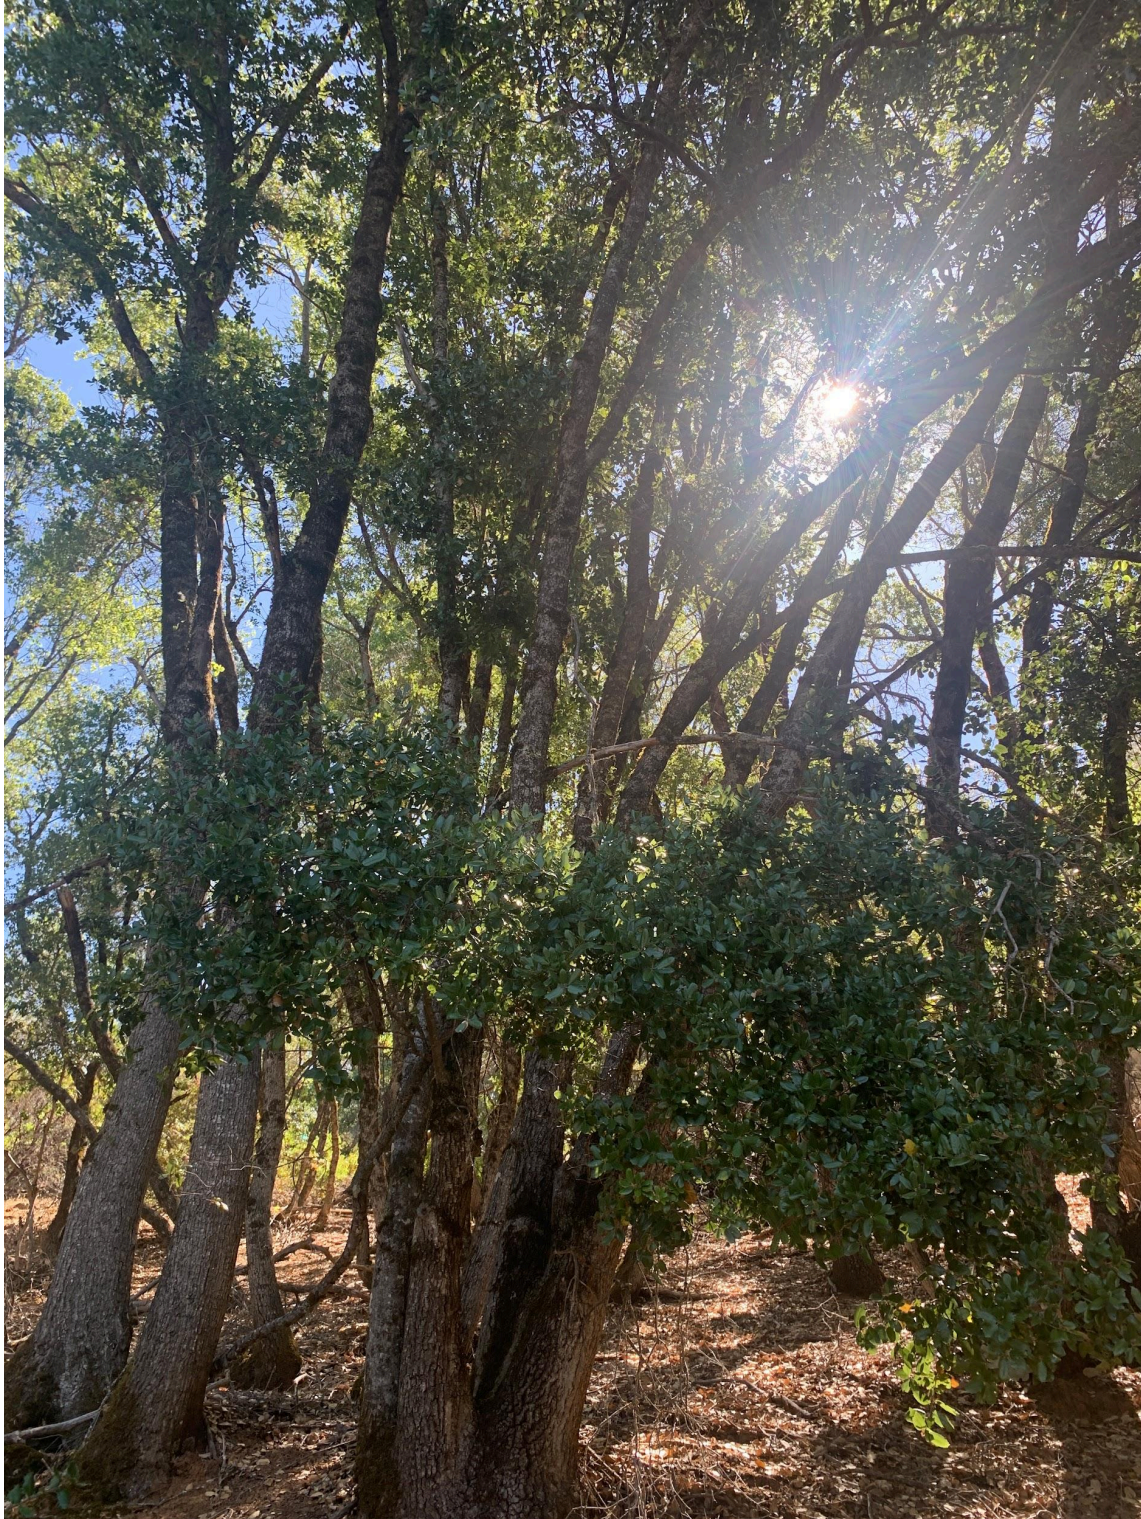
Photo 3. Trees #2 and 3 in poor and fair condition. Both trees are in the proposed road construction plans. Removal is recommend.

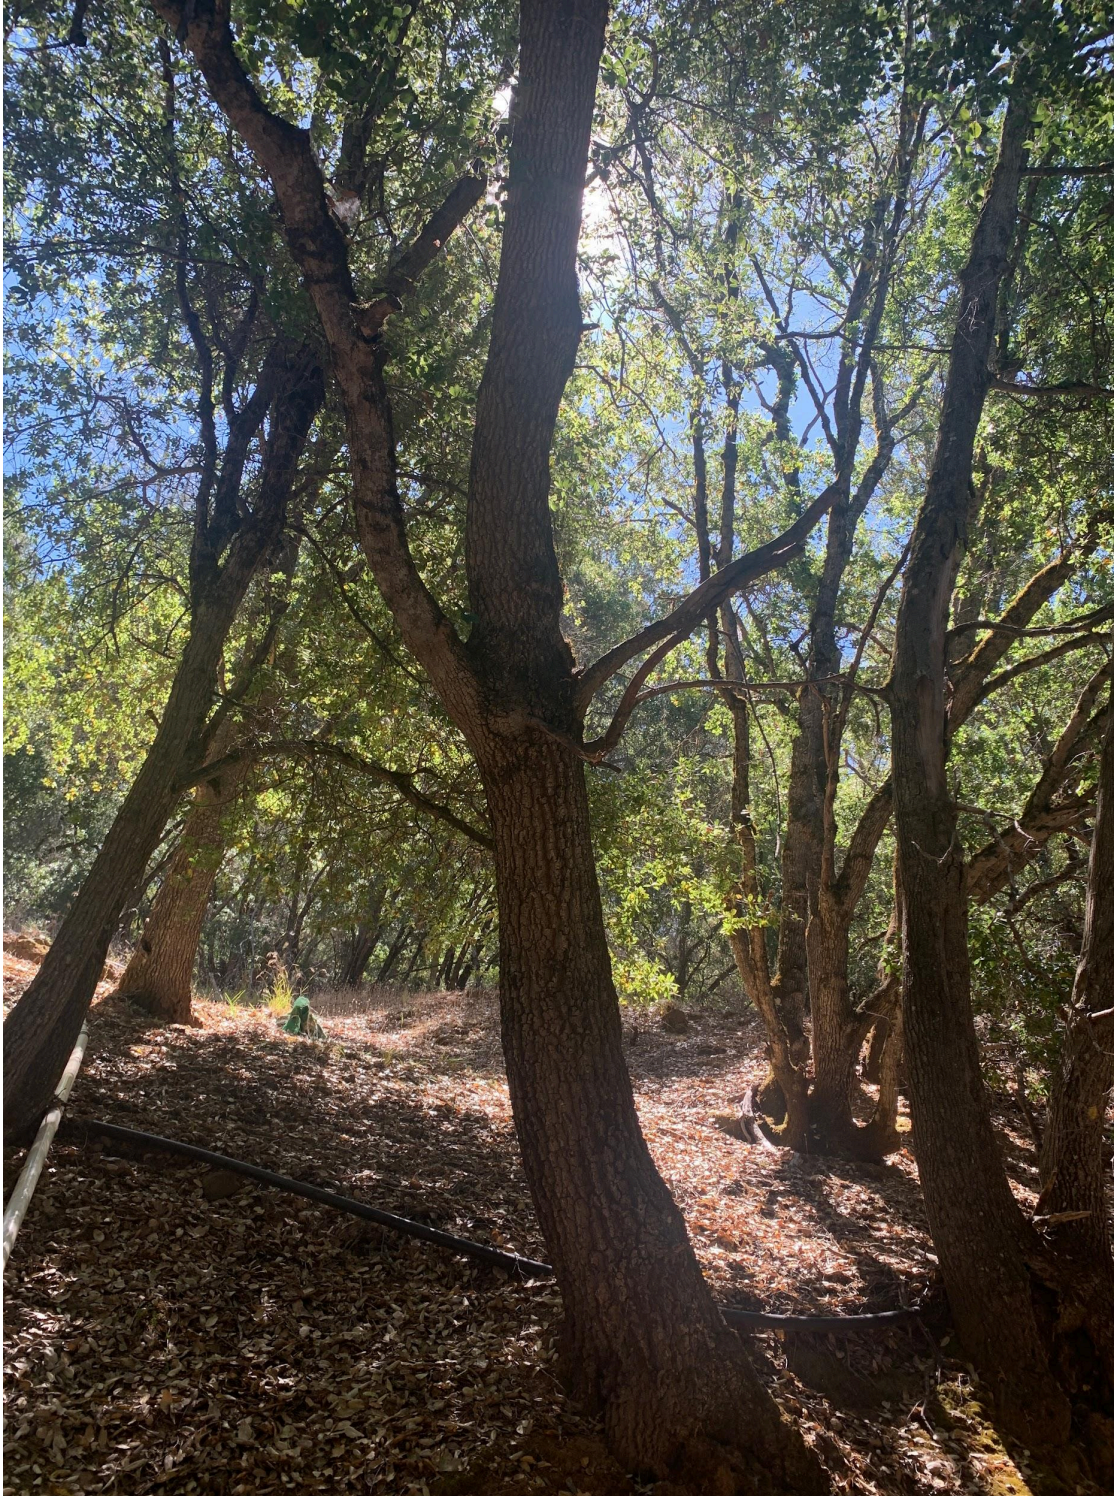
Photo 4. Tree #5 (left) and tree #7 (right) in fair and poor condition. Both trees are in the proposed road construction plans. Removal is recommend.

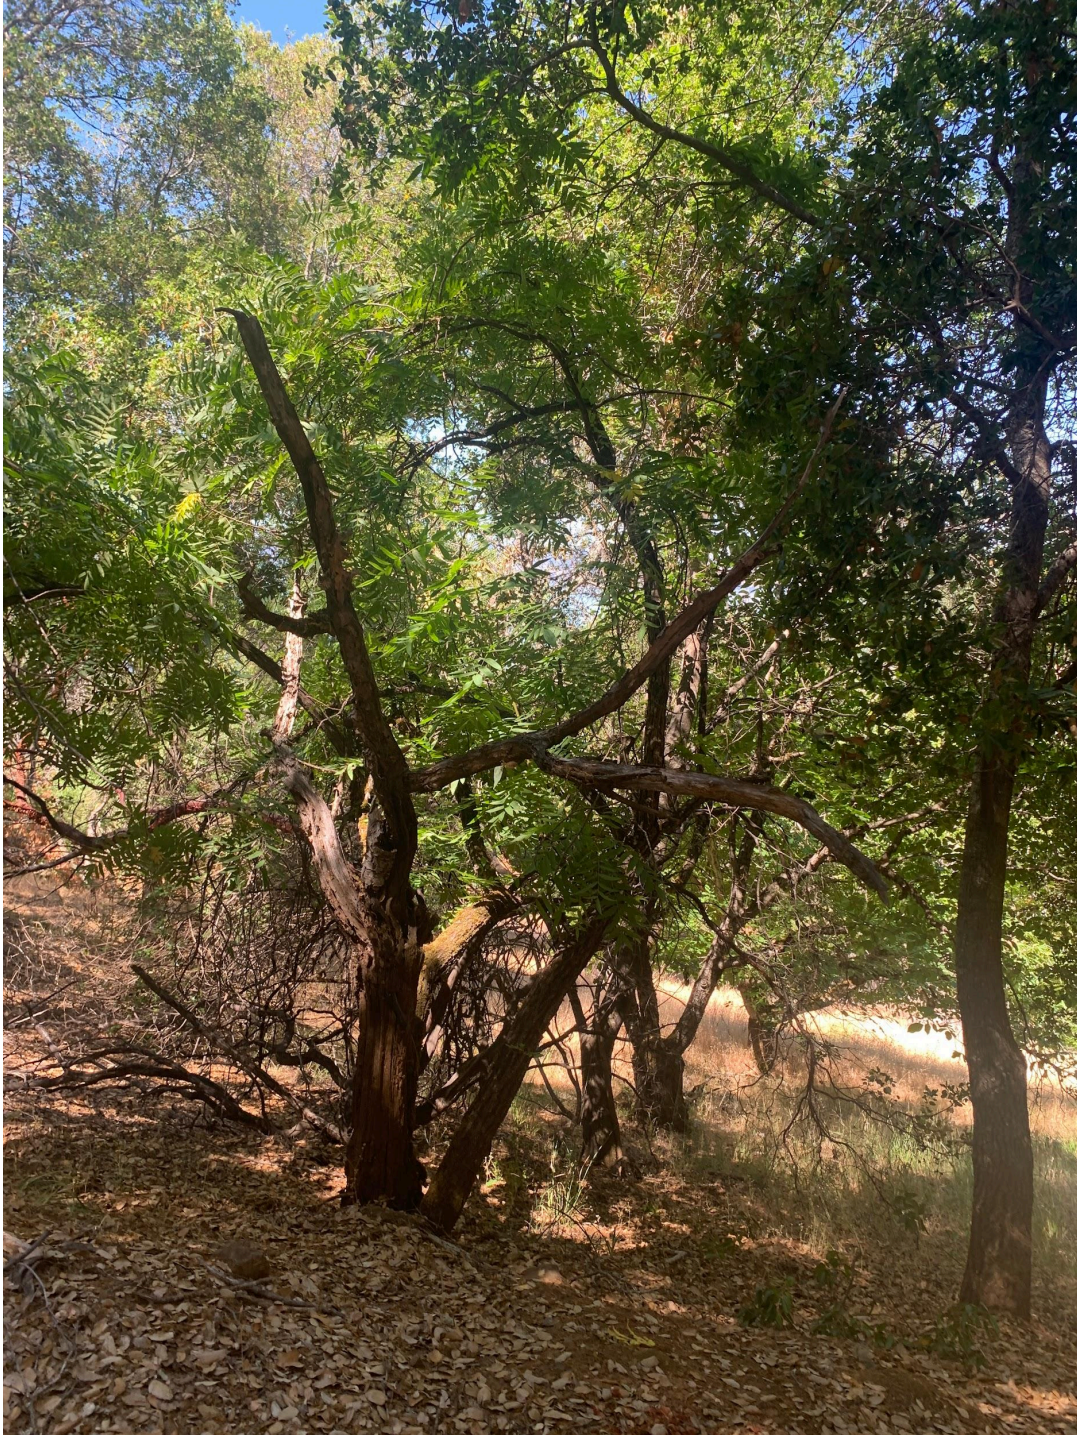
9	7	1	Interior live oak	1	N	
10	6,4,4	3	Chinese pistache	4	Y	3 stems from above ground level, within the road expansion, half dead, and decay in the trunk.
11	9	1	Interior live oak	3	Y	within the road expansion, there is a little bit of decay in the trunk.
12	14, 12 9	3	Interior live oak	3	Y	within the road expansion, decay in the trunk, and dead limbs.
13	22, 13, 8	3	Interior live oak	2	Y	within the road expansion, poison ivy in the tree, hangers, and large deadwood.
14	14	1	Interior live oak	1	Y	within the road expansion; lean
15	13, 5, 4, 3, 10,10,10, 12	8	Interior live oak	2	Y	within the road expansion, small deadwood, decay in the trunk, and unbalanced canopy.
16	5	1	Bay laurel	1	N	
17	10,9,4	3	Interior live oak	2	Y	within the road expansion
18	3,2	2	Manzanita	2	N	small deadwood
19	8	1	Gray pine	2	N	showing signs of stress
20	6,2	2	Interior live oak	2	N	has poison oak in the canopy.
21	32	1	Gray pine	2	N	About 1-2 ft from the road expansion

Photo 6. Tree #10, the tree is half dead, and is in the proposed road expansion.

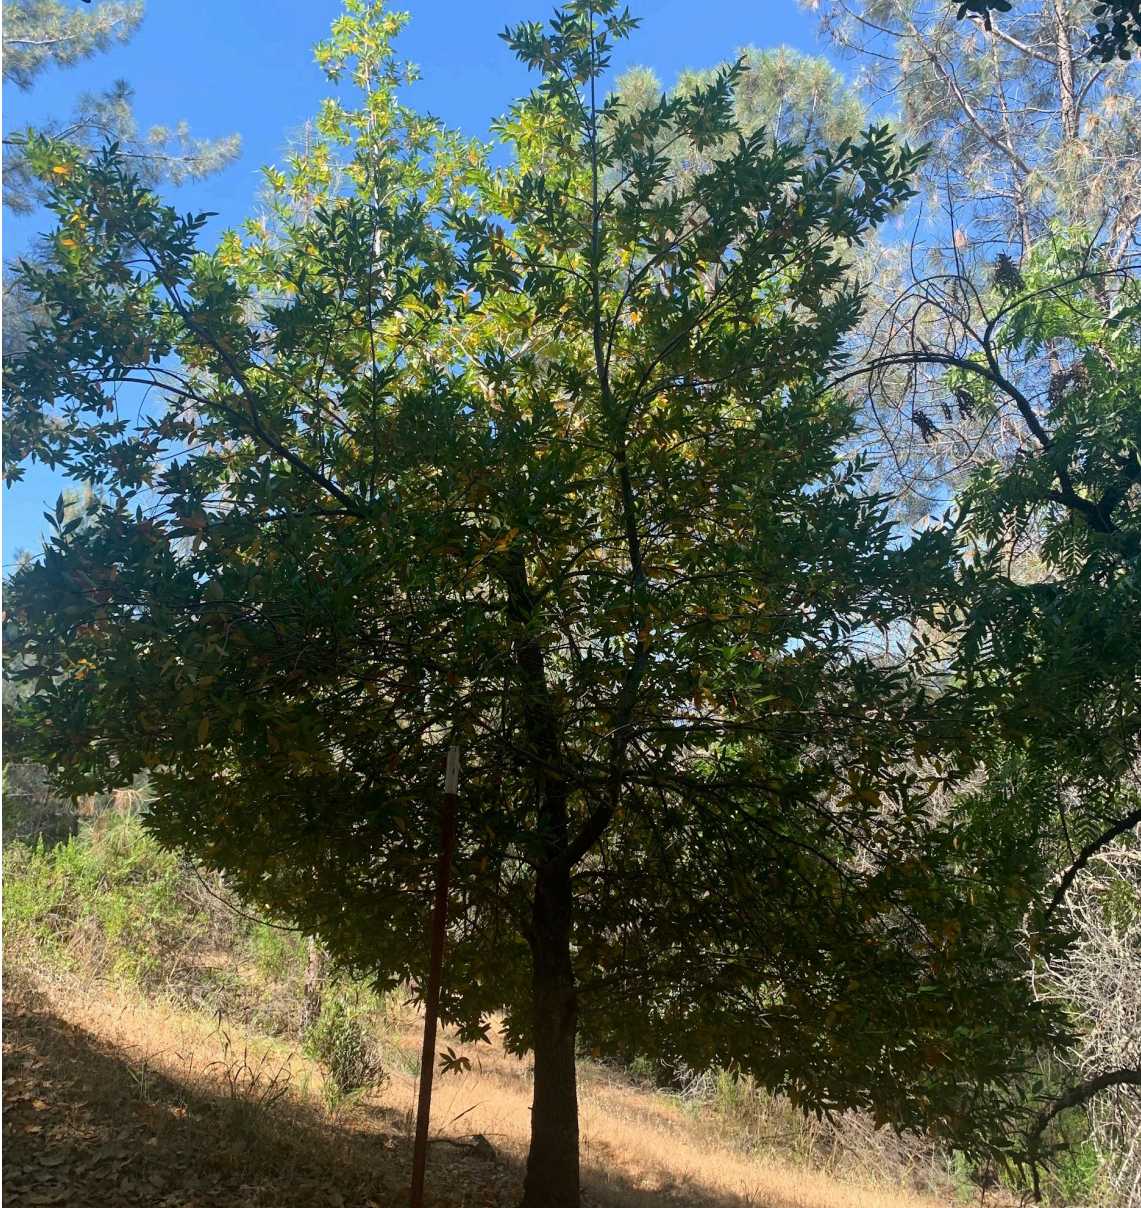
Photo 9. Tree #16 in good condition, but is in the proposed road expansion. Removal is recommended.

- Trees #4, 9, 16, and 18-31 are near the proposed road expansion. The trees are predicted to have low to moderate impacts. Tree protection fencing should be installed at or beyond the driplines as they are close to the project site. Any excavation within the TPZ of trees must be done by hand and supervised by a Certified Arborist. Any necessary pruning shall follow ANSI A300 standards, with no more than 25% of the tree's live tissue removed.

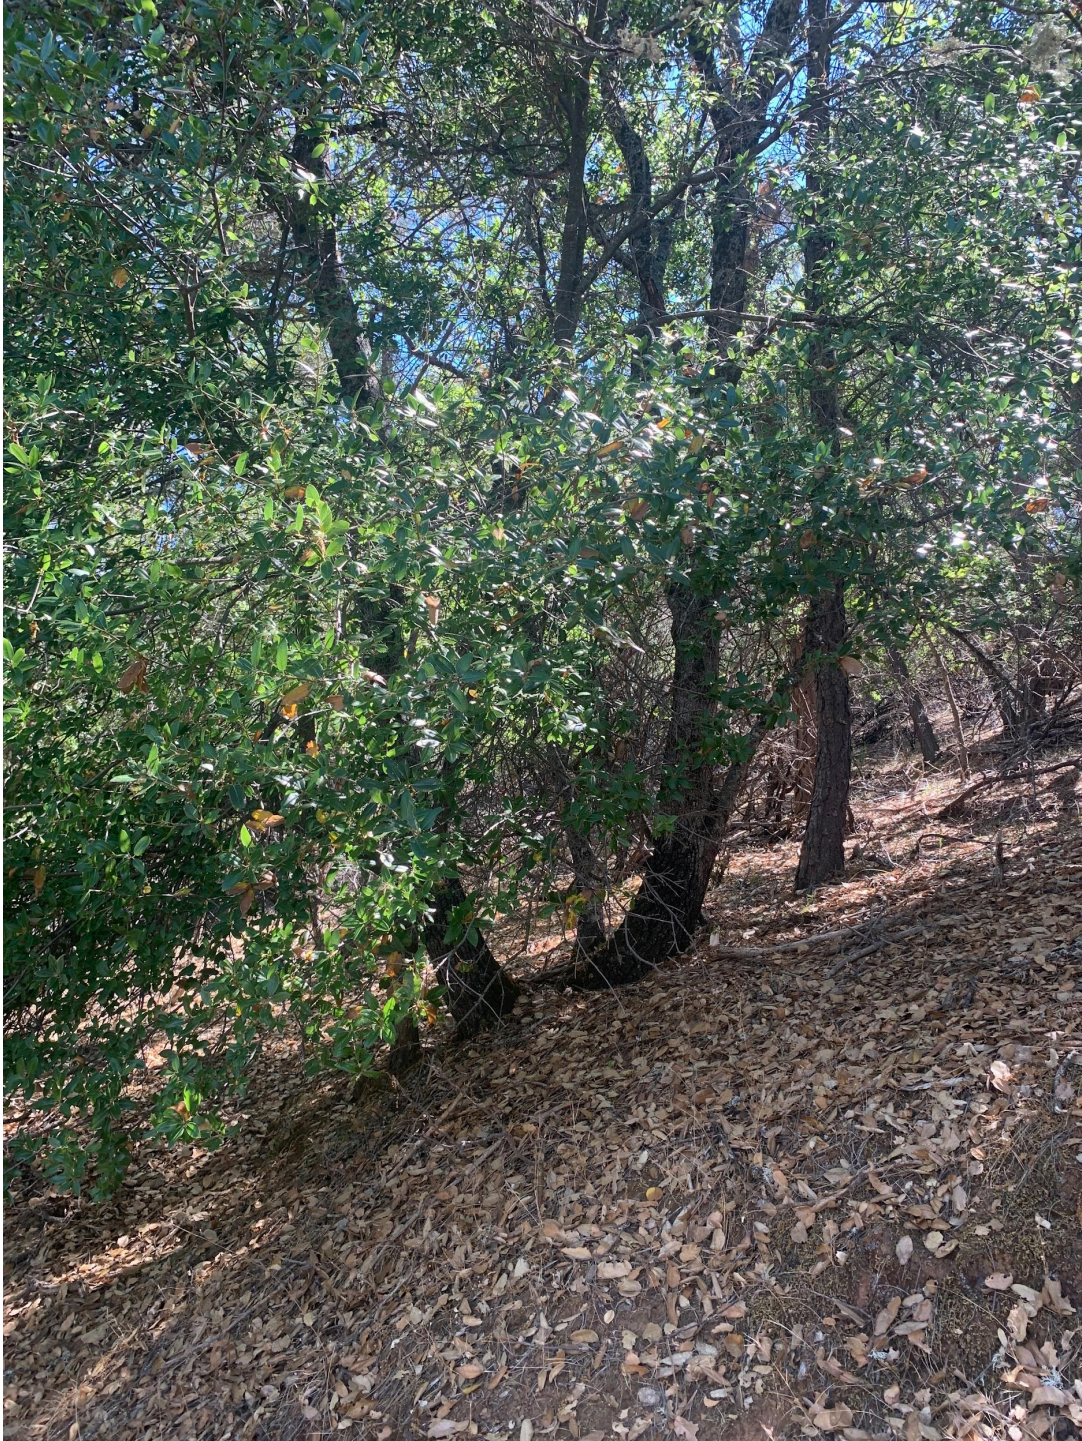
Photo 10. Tree #17 is in fair condition, but is in the proposed road expansion. Removal is recommended.

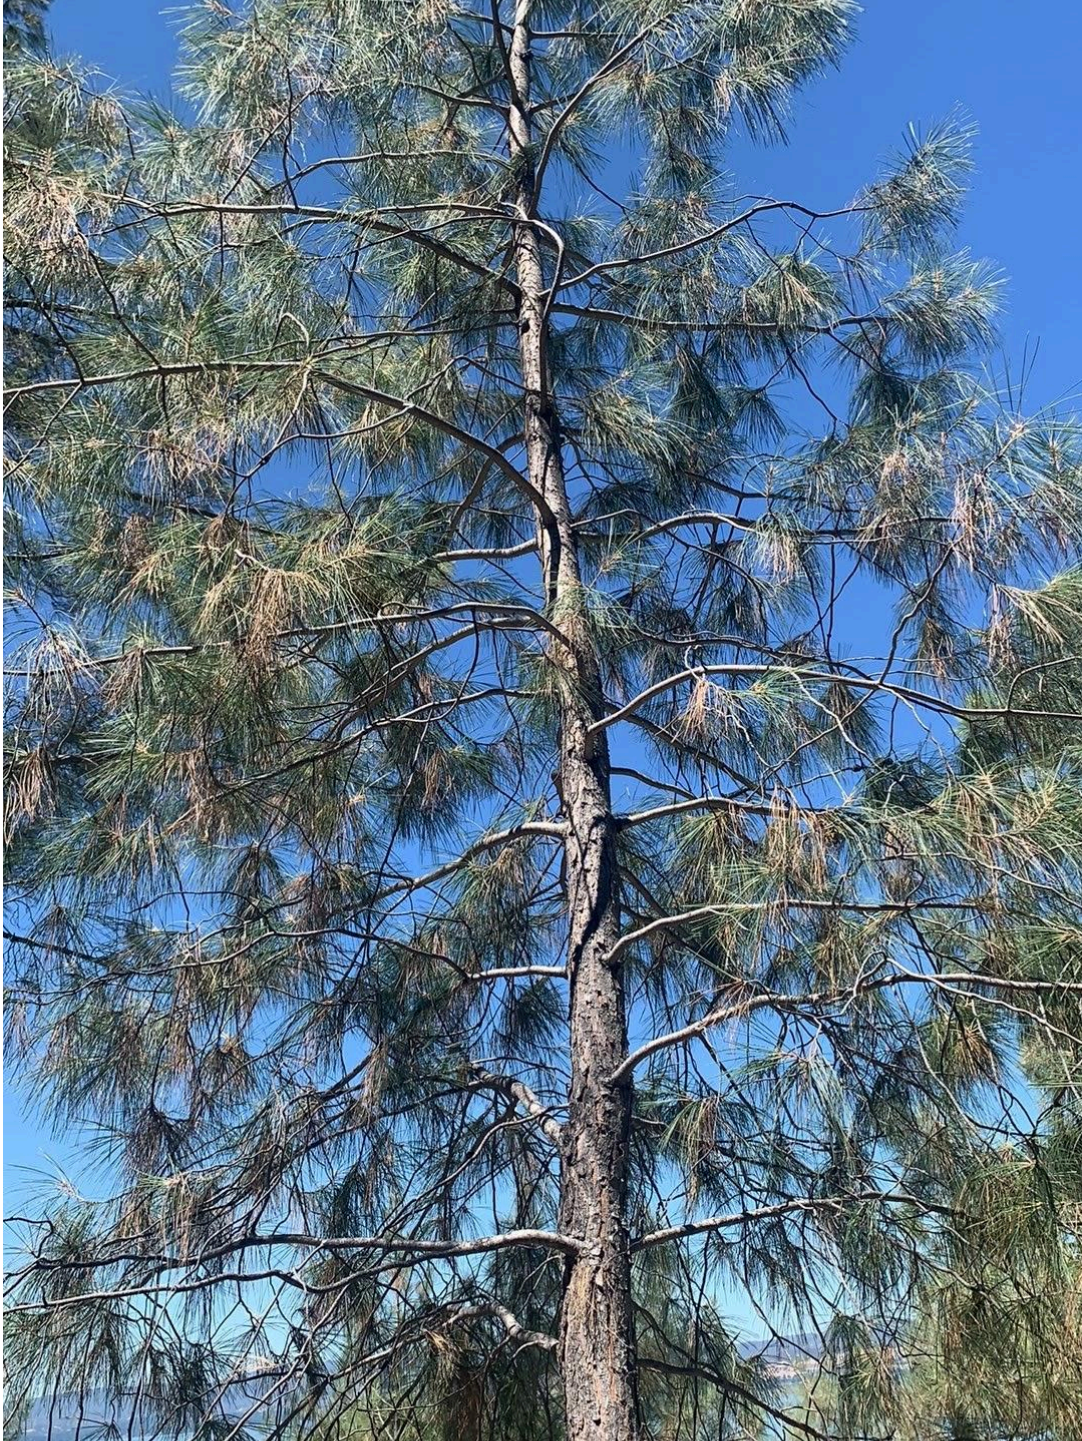
Photo 11. Tree #24 is in fair condition, but is in the proposed road expansion. Removal is recommended.

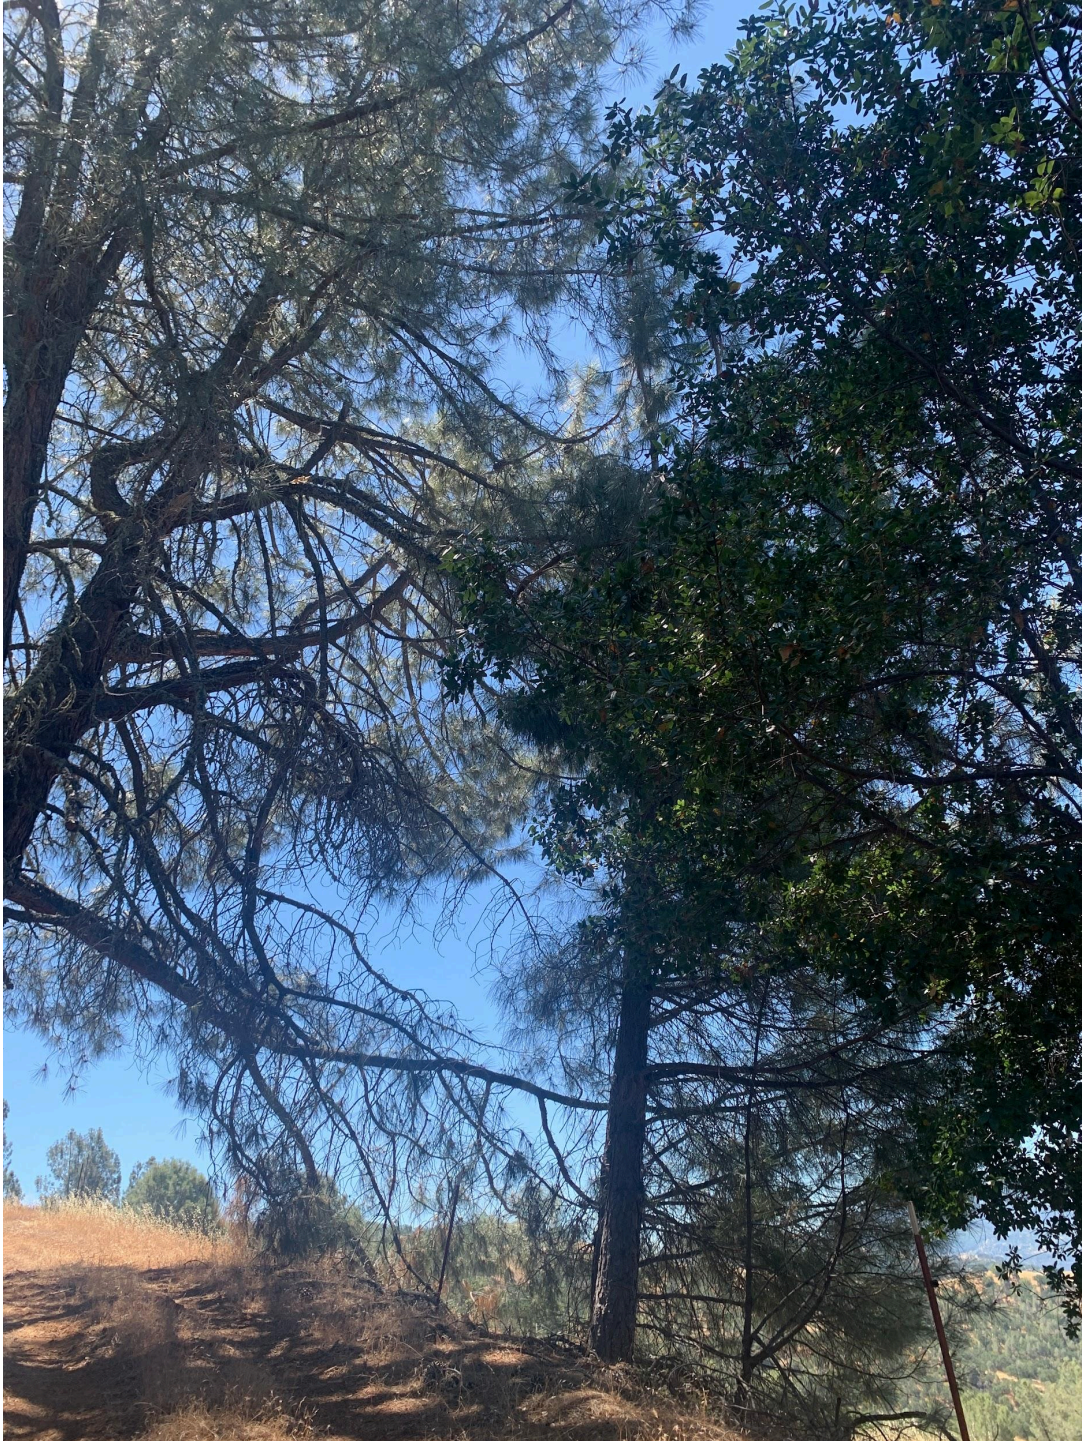
Photo 14. Trees 29 (right) and tree 32 (left) are in good and fair condition. They are located in the proposed road expansion. Removal is recommended.

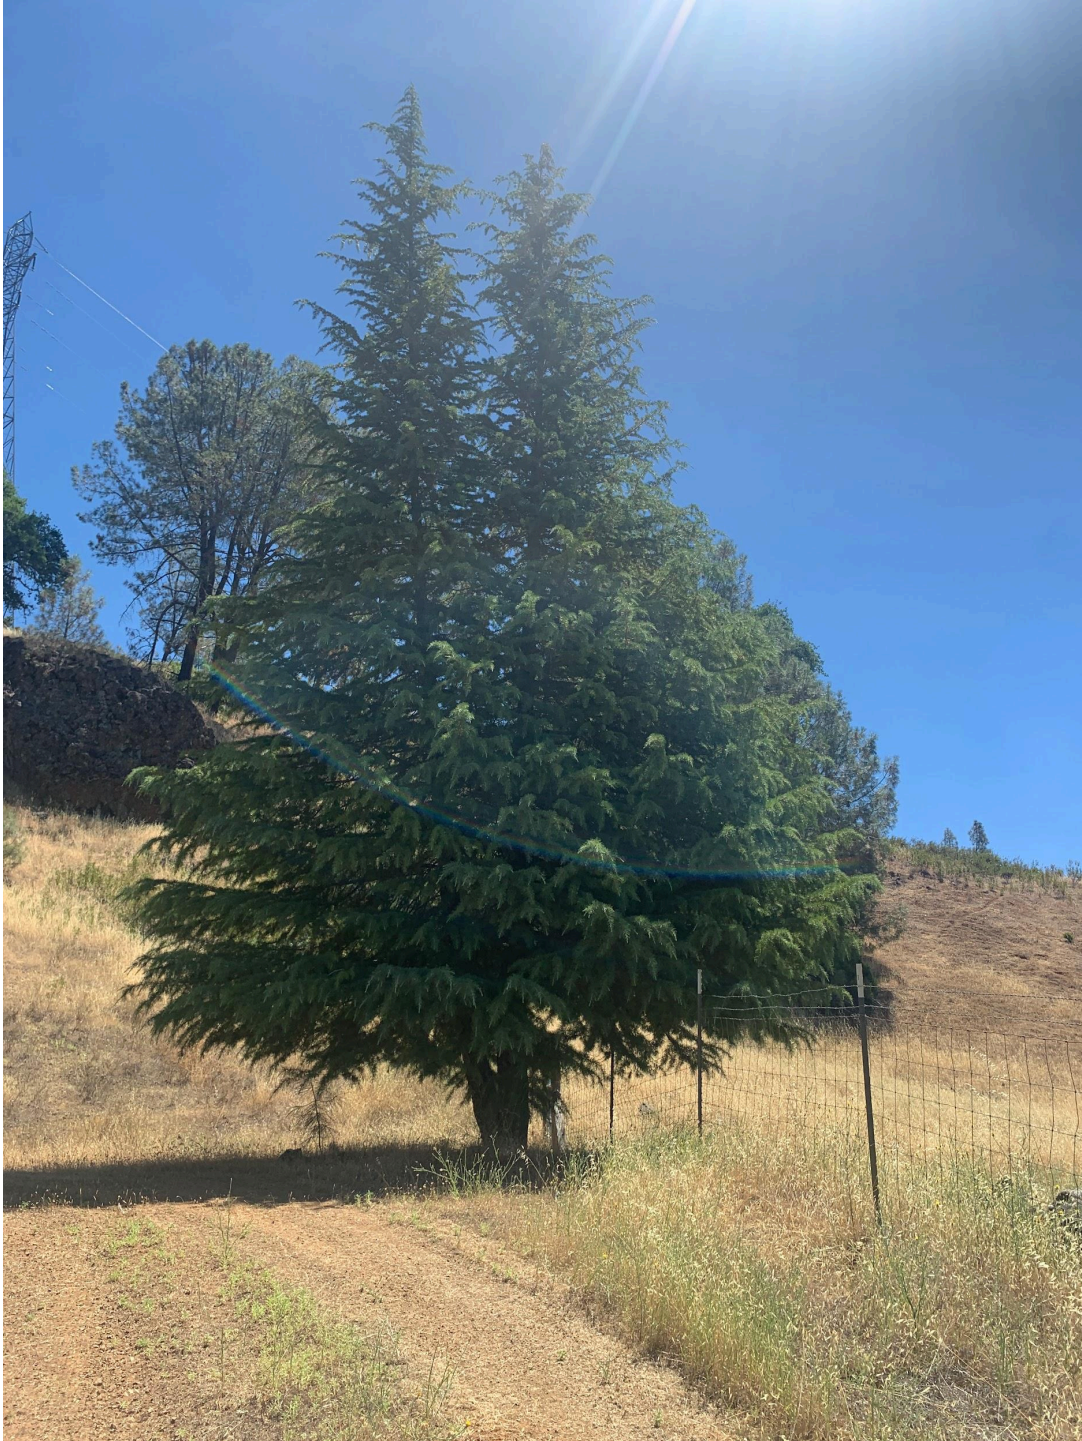
Photo 17. Tree #34 a is in good condition. The tree is right outside the path of the road expansion. Impacts are predicted to be moderate.

- Trees #34-36 are near the proposed pad of the new tower. The trees are predicted to have low to moderate impacts. Tree protection fencing should be installed at or beyond the driplines as they are close to the project site. Any excavation within the TPZ of trees must be done by hand and supervised by a Certified Arborist. Any necessary pruning shall follow ANSI A300 standards, with no more than 25% of the tree's live tissue removed.
