# ARBORIST REPORT AND TREE PROTECTION PLAN

CA-7286  
5017 Terrace Ave.  
Lakeport, CA

December 2023

Arborist Report & Tree Protection Plan for  
5017 Terrace Ave. (CA-7286)  
Lakeport, CA

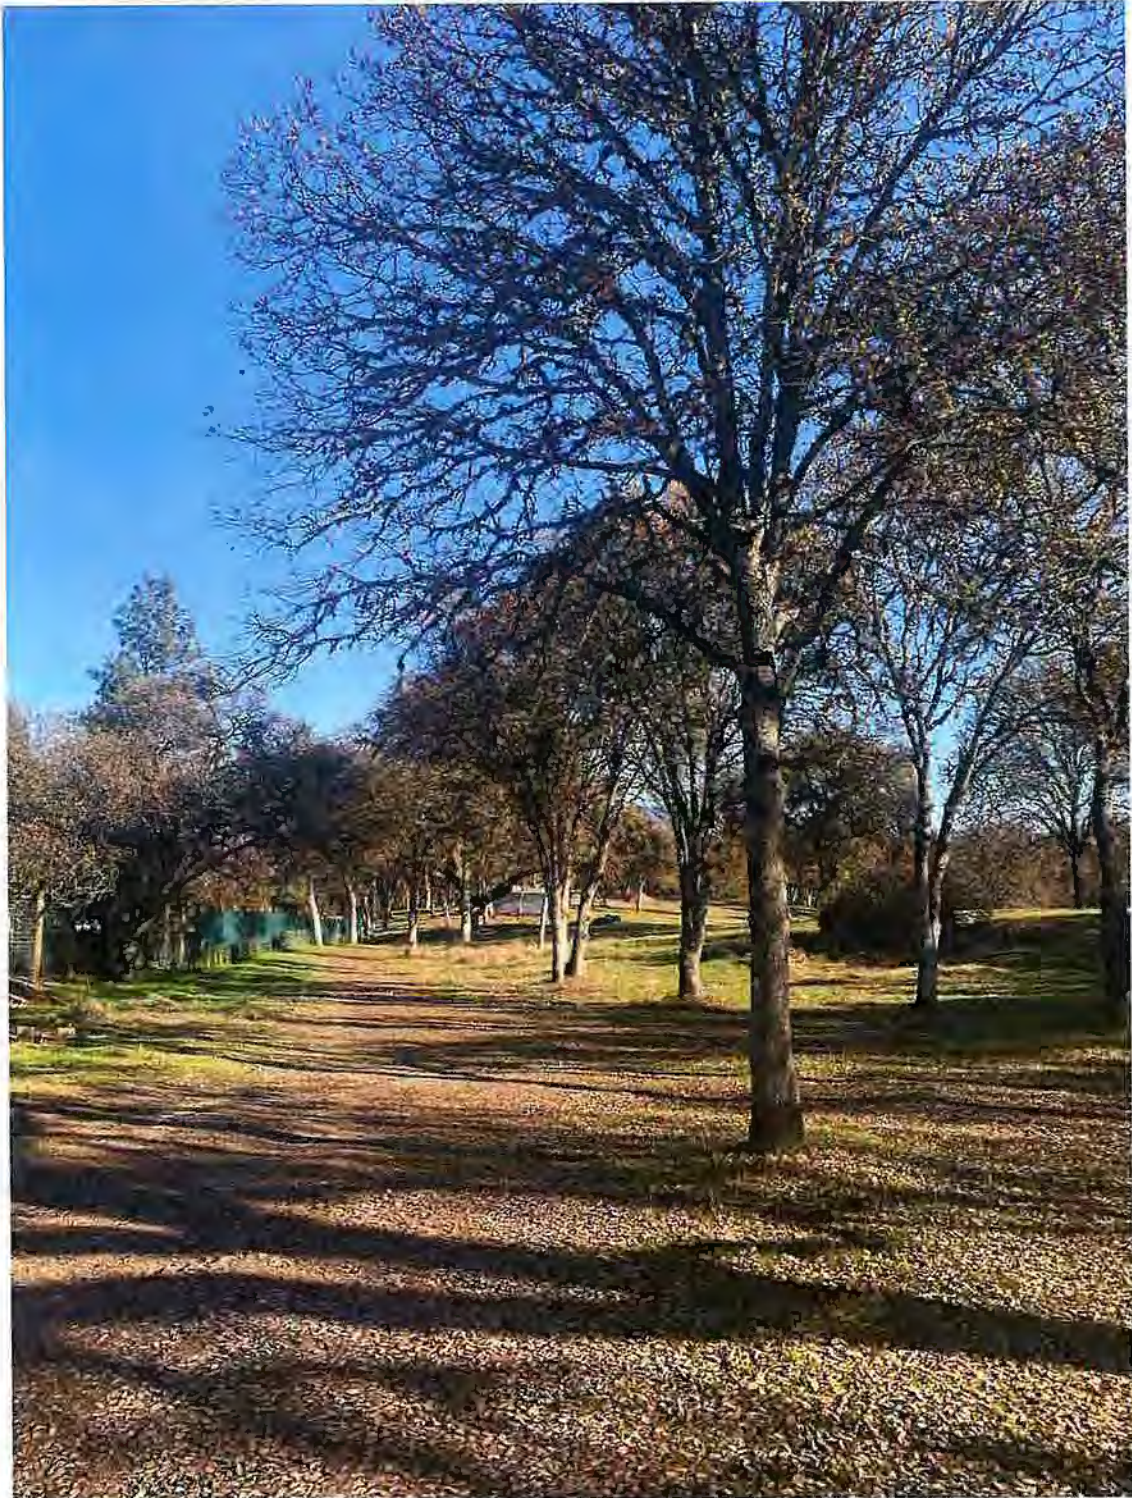
**Photo 1. Several oaks adjacent to the existing unimproved access road. Tree #25 (foreground)**

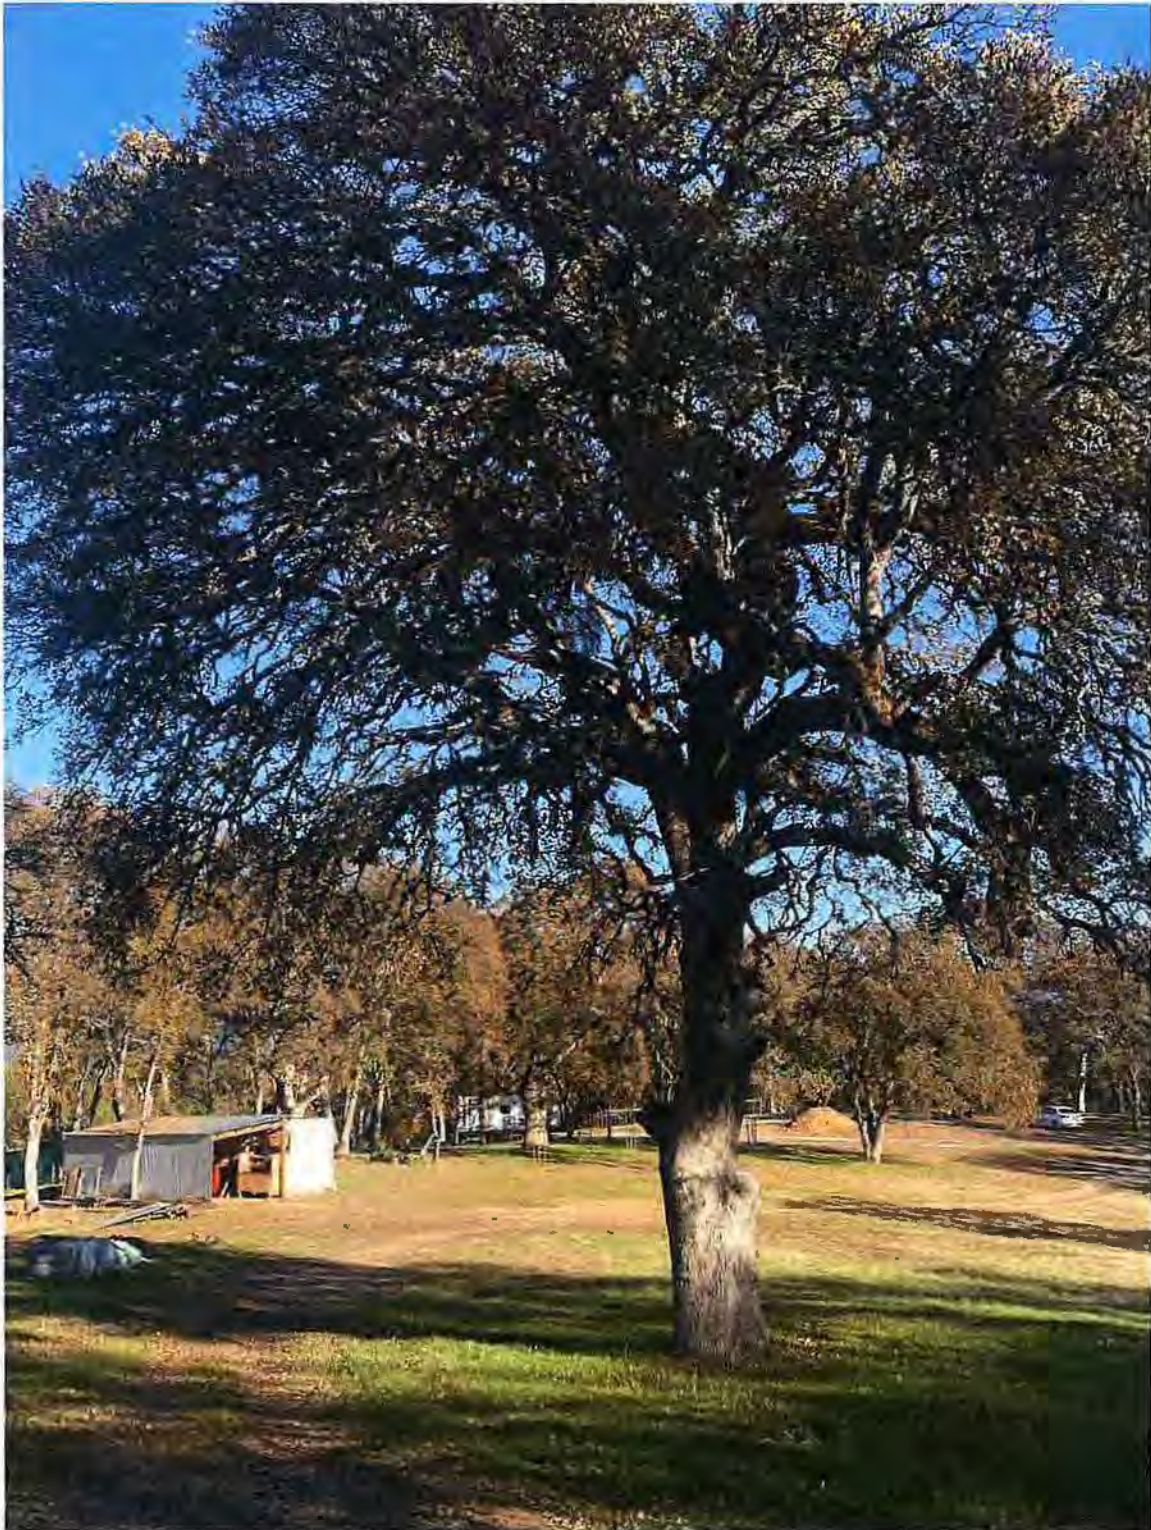
**Photo 2. Tree #31 is 10 feet from existing path and proposed gravel road. Tree protection measures outlined in this report shall be followed to minimize impacts from compaction within the TPZ and potential compaction within the SRZ.**

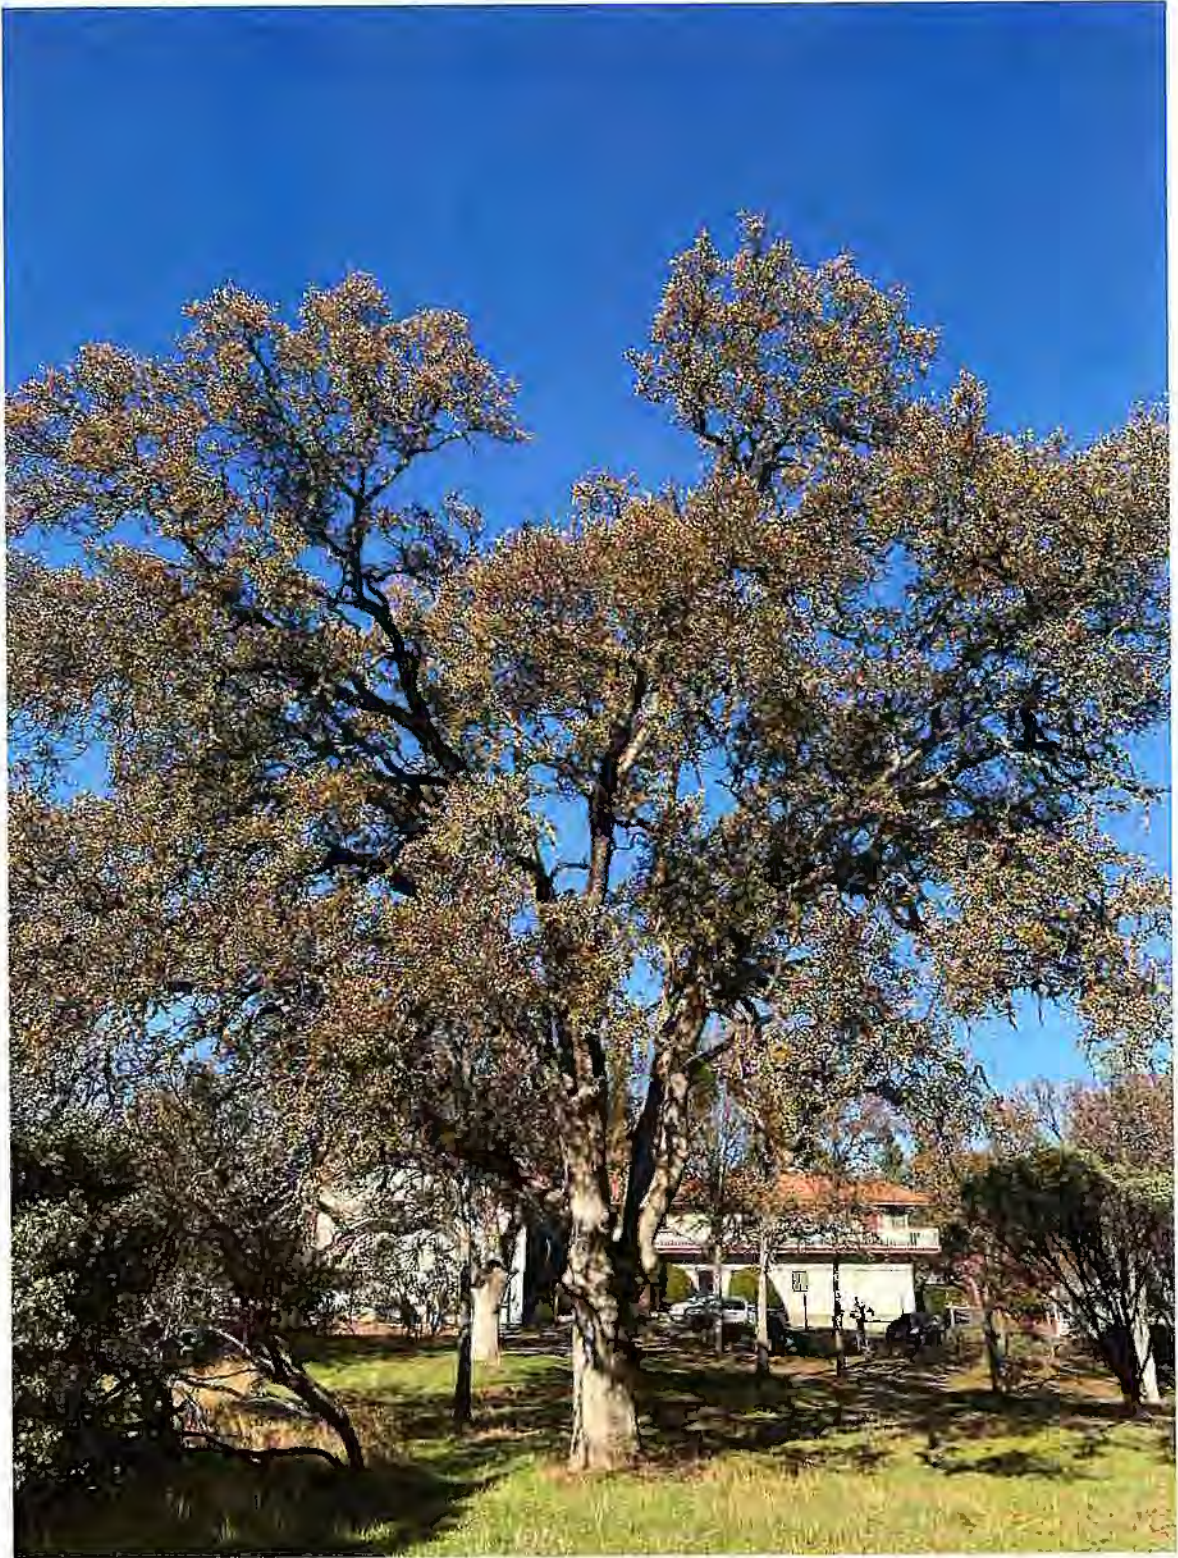
**Photo 3. Tree #19 is a large blue oak in fair condition and is not expected to be impacted by construction.**

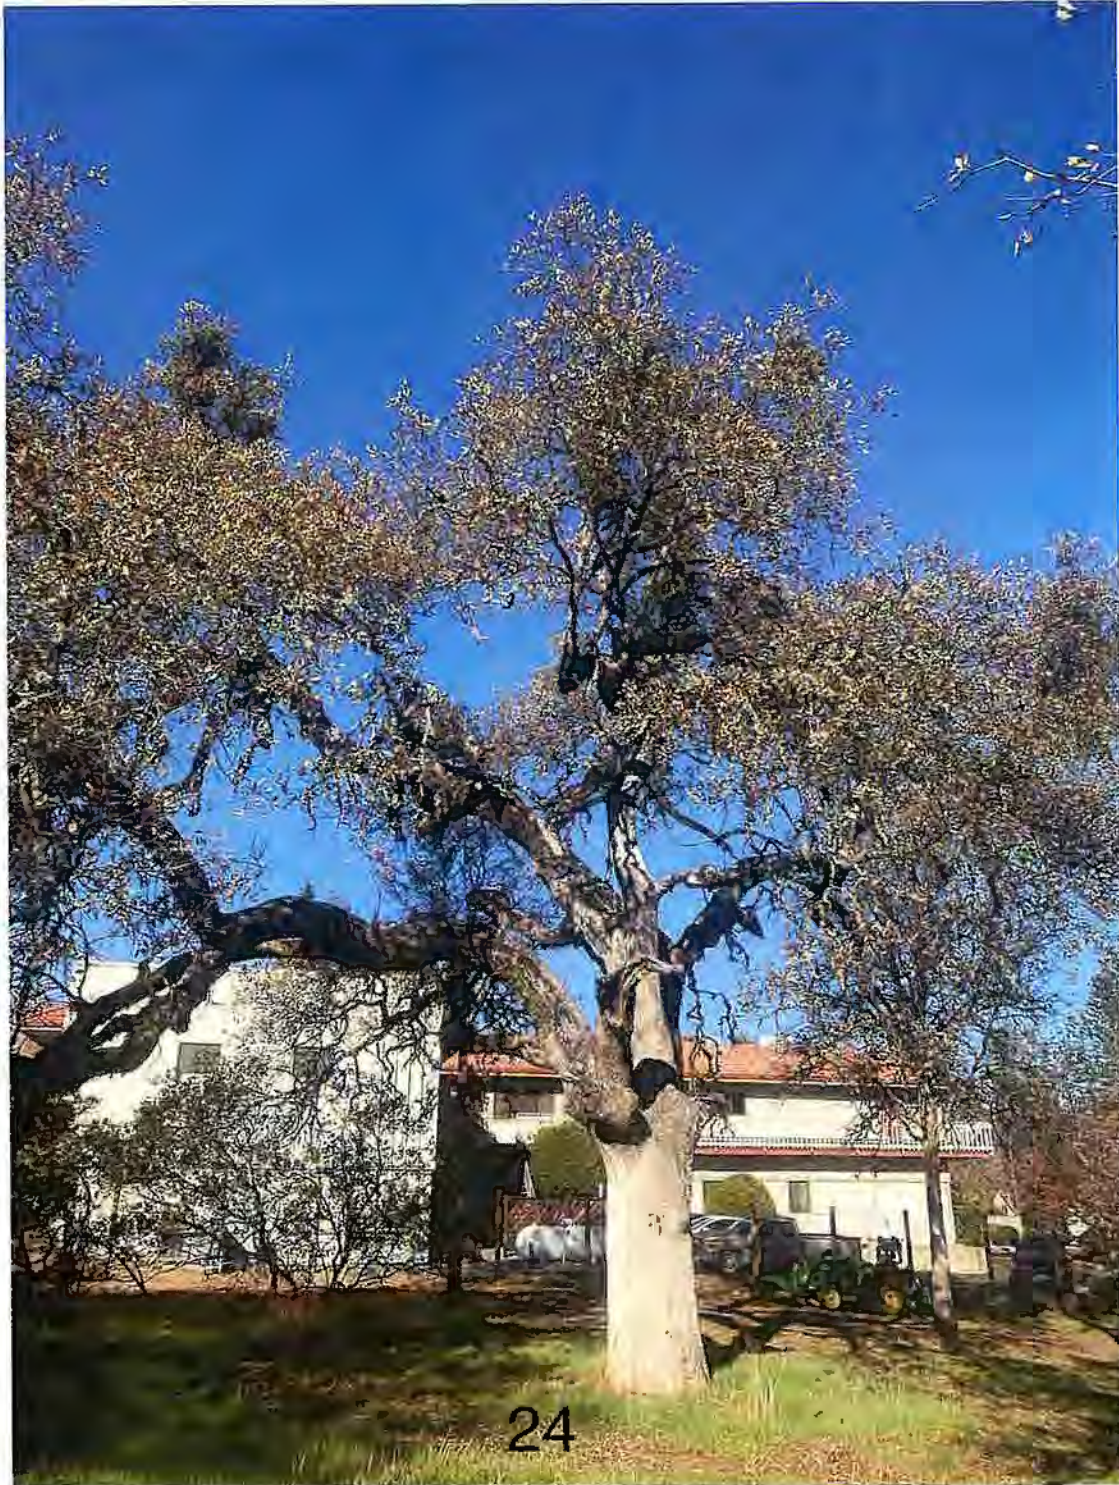
**Photo 4. Tree #24 had previous large branch failures and is listed as in fair condition. This tree is near proposed road construction (drawing A2 from site plan) and will need tree protection if construction occurs within the TPZ.**

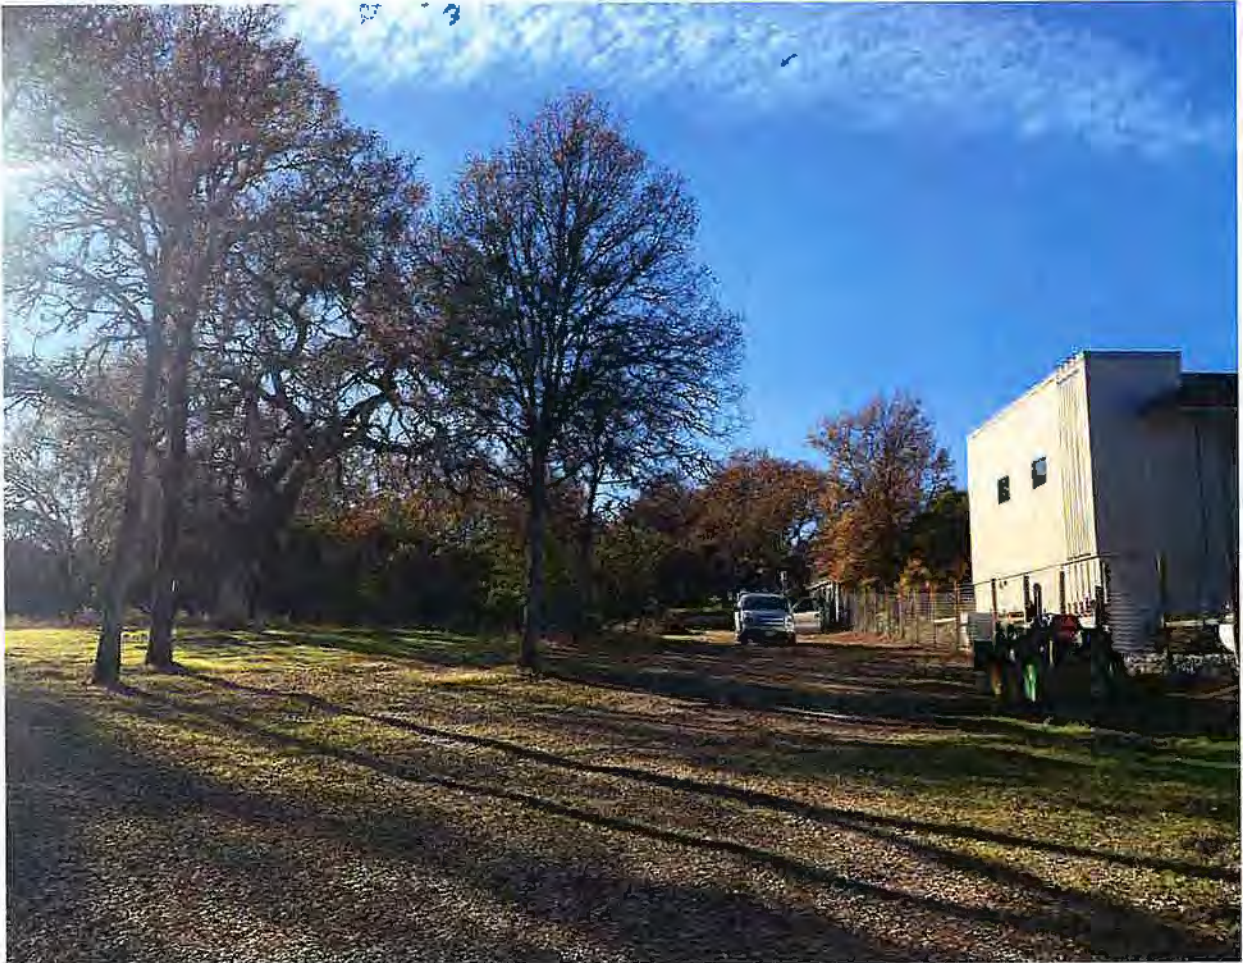
**Photo 5. Another view (west) with trees #43, #44 and #29 pictured near existing and proposed road construction. TPZ and 5RZ impacts are expected.**

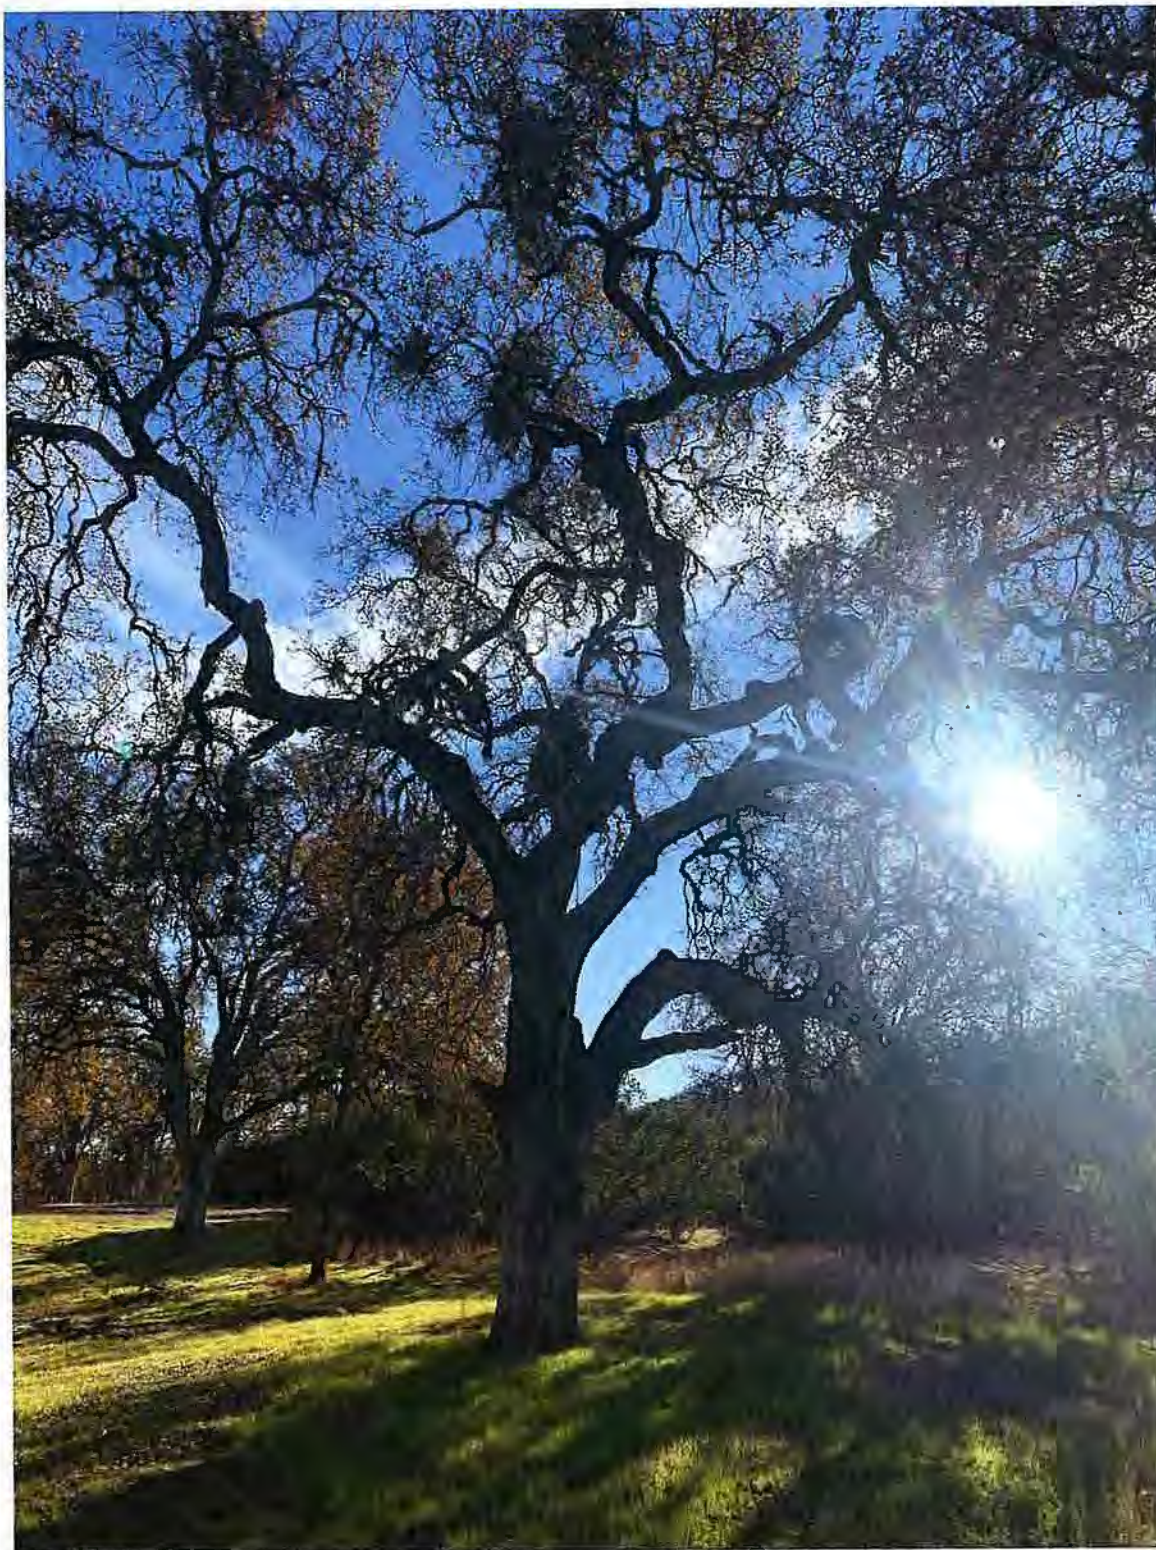
**Photo 6. Another angle of tree #24. Deadwood over 2" diameter should be trimmed and removed.**

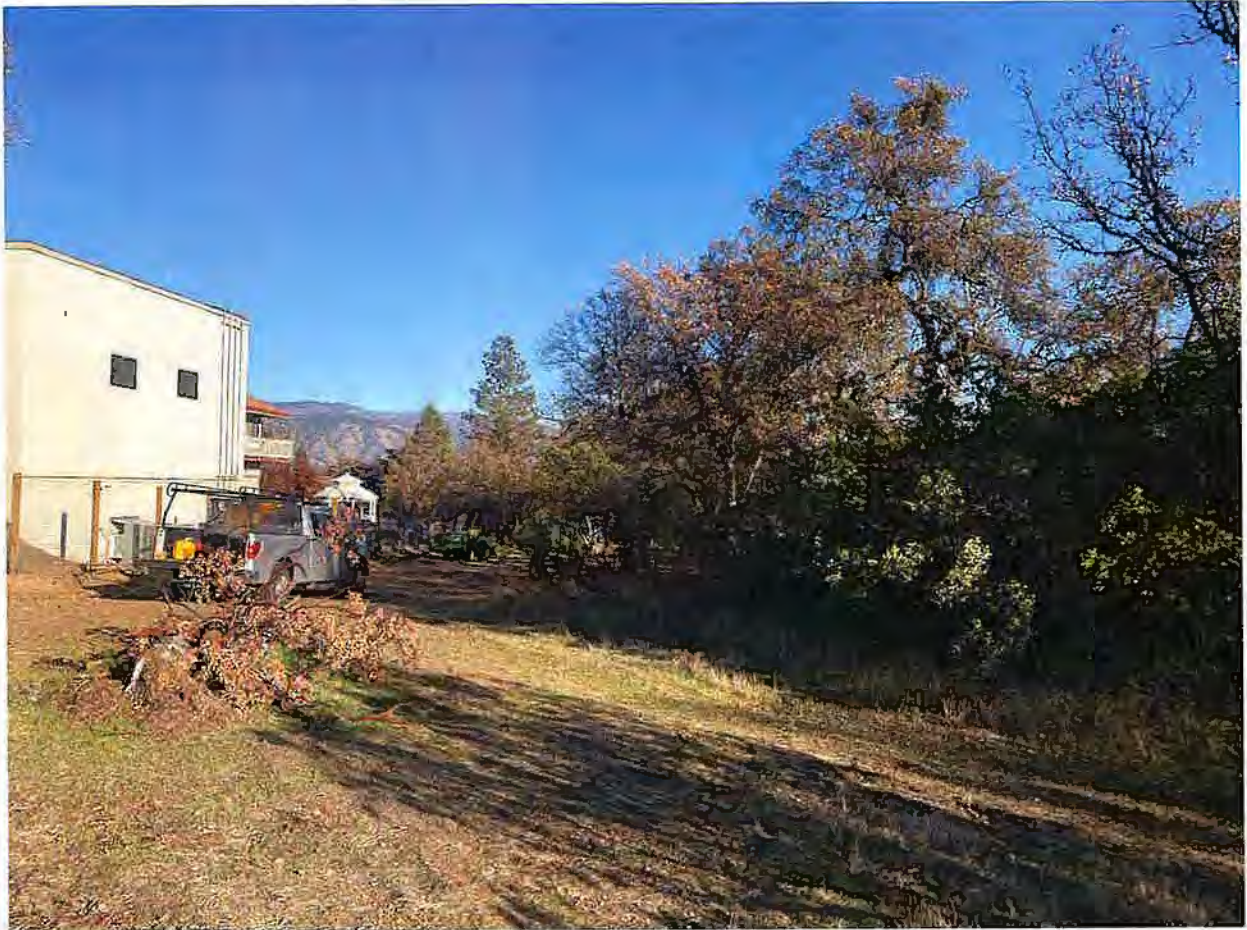
**Photo 7. Area of proposed fenced compound lease area adjacent to trees #26-#28. Any construction within the TPZ of these trees must follow tree protection measures.**

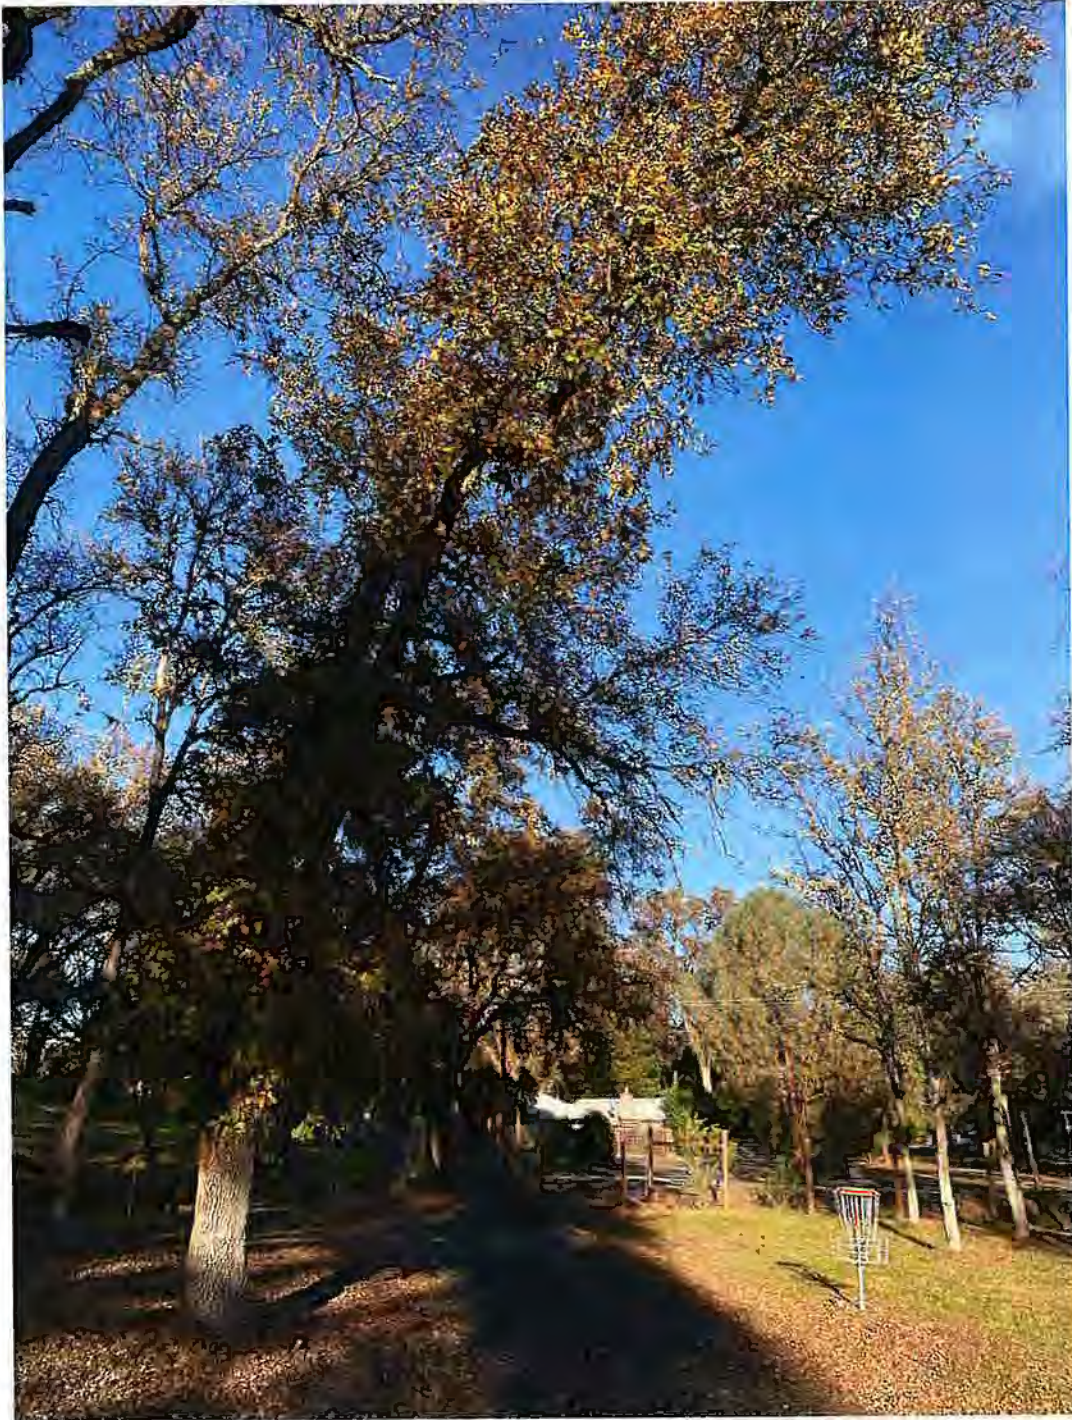
**Photo 8. Tree #50 is leaning over the road near the entrance to the property. Impacts within the TPZ and SRZ from road construction are expected.**
