DEPARTMENT OF WATER RESOURCES

FEDERAL EMERGENCY MANAGEMENT AGENCY COMMUNITY ASSISTANCE VISIT REPORT

**NATIONAL FLOOD INSURANCE PROGRAM
COMMUNITY ASSISTANCE VISIT
PART B - NARRATIVE**

Lake County, California
March 28, 2019

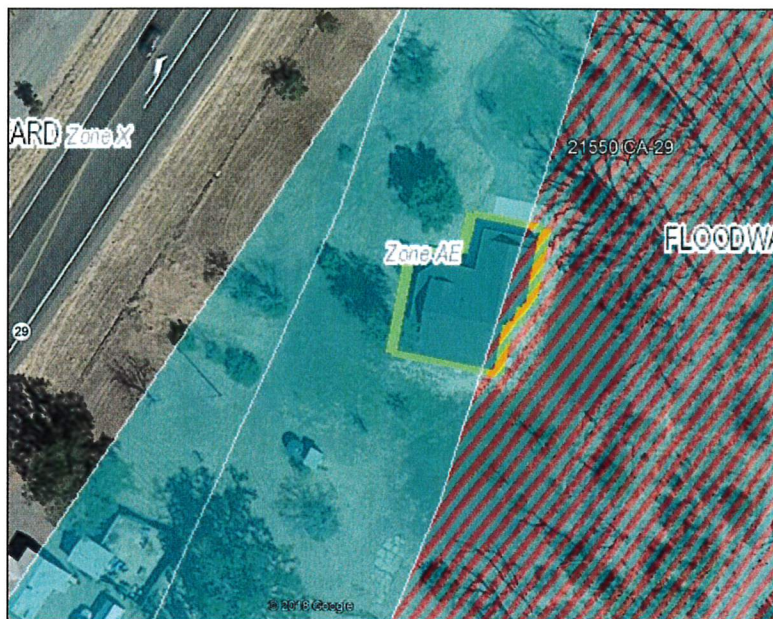
14) 21550 CA HWY 29, Middletown

The development is non-compliant with the County's 1-foot freeboard requirement for lowest floor based on the data provided. The FIRM shows the structure is partially located within the floodway.

The EC indicates that the structure is located within Zone AO-2; however, based on review of the FIRM, the structure is located within Zone AE. The BFE is approximately 1,123 feet based on the flood profile.
