December 10, 2021 - DRAFT Job No. 3964.0

> Geotechnical Consultation Proposed Development Highland Farms Highland Springs Road Lakeport, California

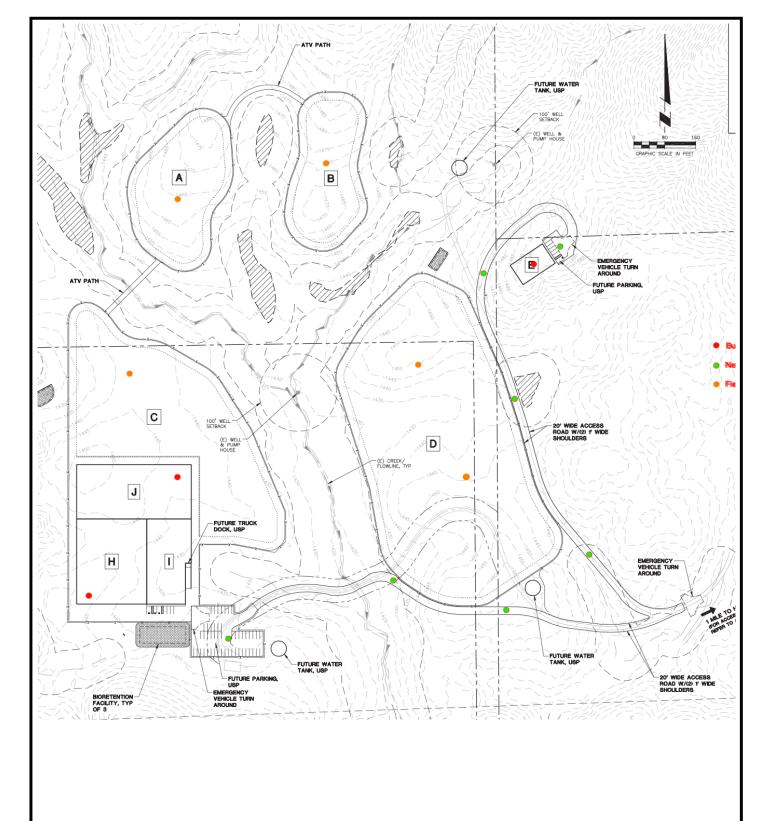
BAUER ASSOCIATES, INC.	Job No	3964.0	SITE MAP	PLATE
	Date:	12/21	HIGHLAND SPRINGS ROAD	l ₄
GEOTECHNICAL CONSULTANTS	Ву:	SJK	Lakeport, California

The proposed development area is located about 1 mile west of the Highland Springs Reservoir (approximate site coordinates: 38.941523° N; -122.929765° W). The proposed development area are shown on Plate 1.
