December 10, 2021 - DRAFT Job No. 3964.0

> Geotechnical Consultation Proposed Development Highland Farms Highland Springs Road Lakeport, California

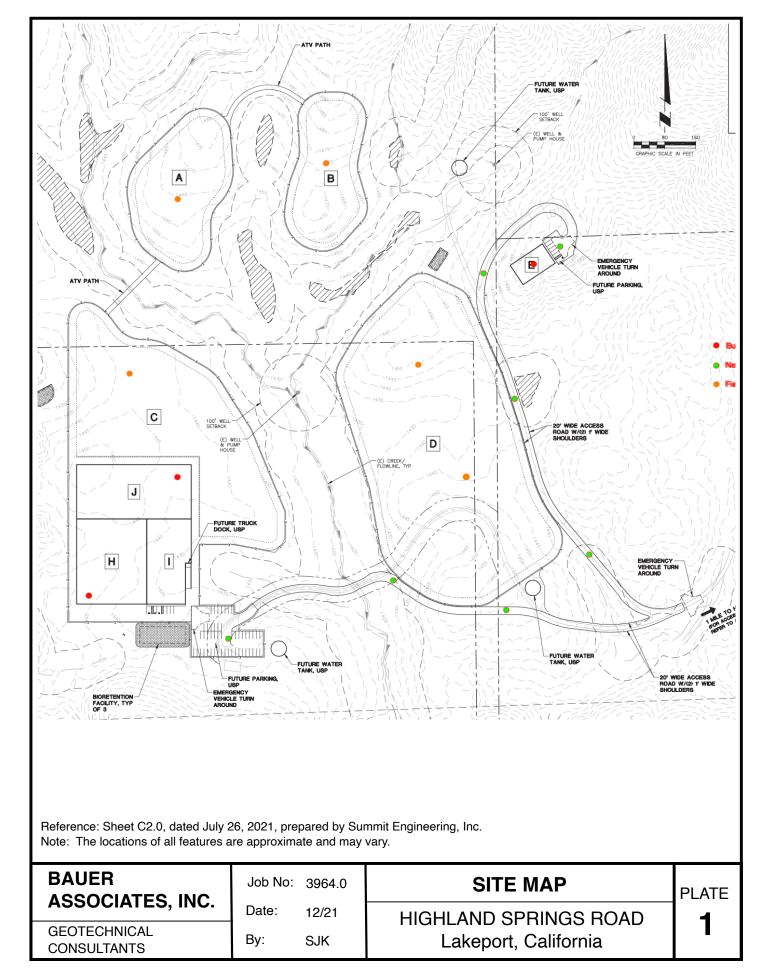
The proposed development area is located about 1 mile west of the Highland Springs Reservoir (approximate site coordinates: 38.941523° N; -122.929765° W). The proposed development area are shown on Plate 1.
