# **BIOLOGICAL RESOURCES ASSESSMENT**

**3417 & 3547 HENDRICKS ROAD [APN 005-013-01 & 005-006-07]  
LAKE COUNTY, CALIFORNIA**

PROJECT № LAK018

AUGUST 20, 2024

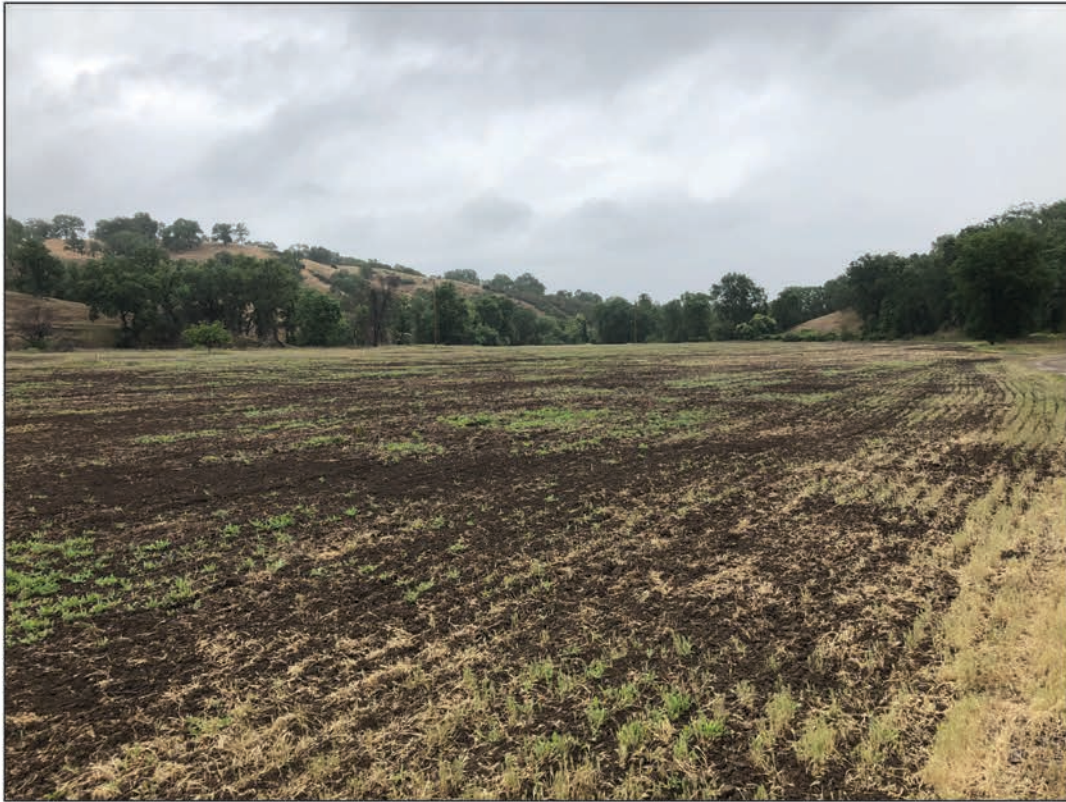
**FIGURE 4: PHOTOGRAPH OF EAST CULTIVATION AREA**

The east and west hayfields are the proposed location for the cultivation facilities, and have been disked annually for many decades. The species composition and topography is reflective of this high intensity cultivation over many years, and is dominated by forage crops, interspersed with some native herbaceous species. The east field was recently disked while the west field was not disked this year but did have evidence of a fenceline where the fence and invasive grass had been removed the year prior at the request of the County, as part of invasive species abatement measures.

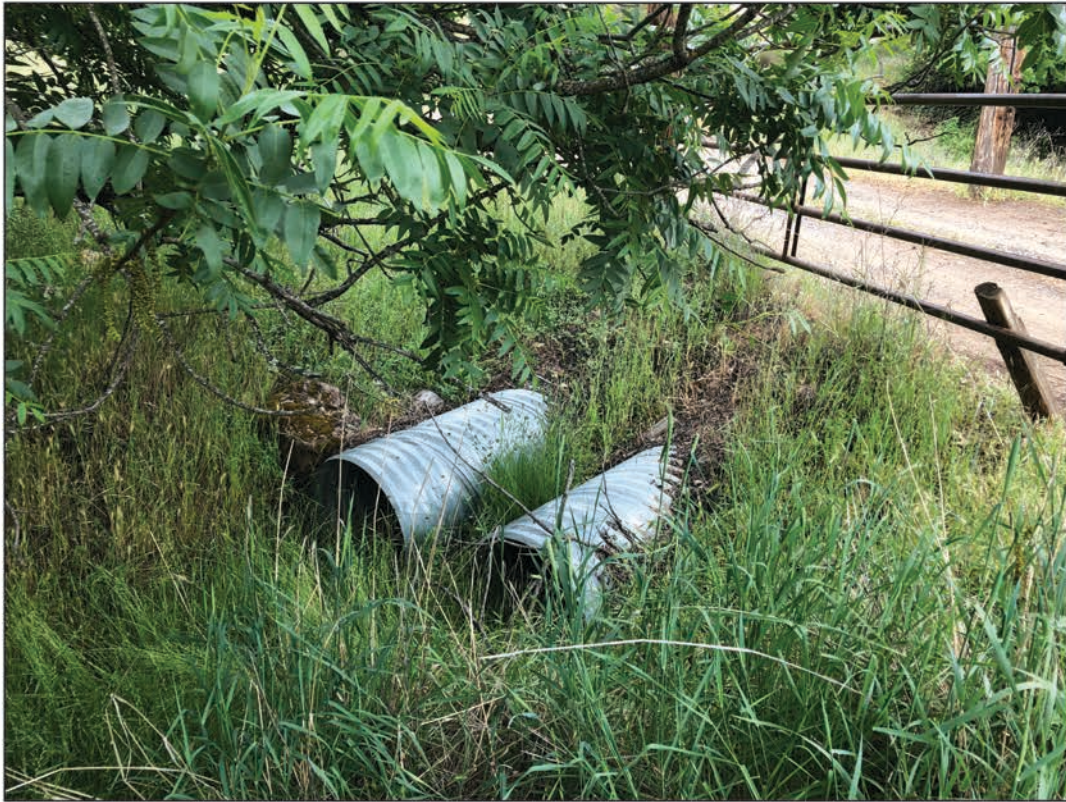
**FIGURE 6: PHOTOGRAPH OF CULVERT**

No discharges of sediment or fill are predicted to any watercourses or other waters of the State or waters of the U.S. There is one culvert crossing that does not appear to be actively eroding. As long as 100 foot setbacks are observed off Hendricks Creek and the other mapped drainages there should be no impacts to downstream water quality. There are no potential wetlands or watercourses in the proposed cultivation areas. As long as appropriate setbacks are observed off of all watercourses as required by State Water Resources Control Board *Cannabis* General Order, no impacts to watercourses should occur.

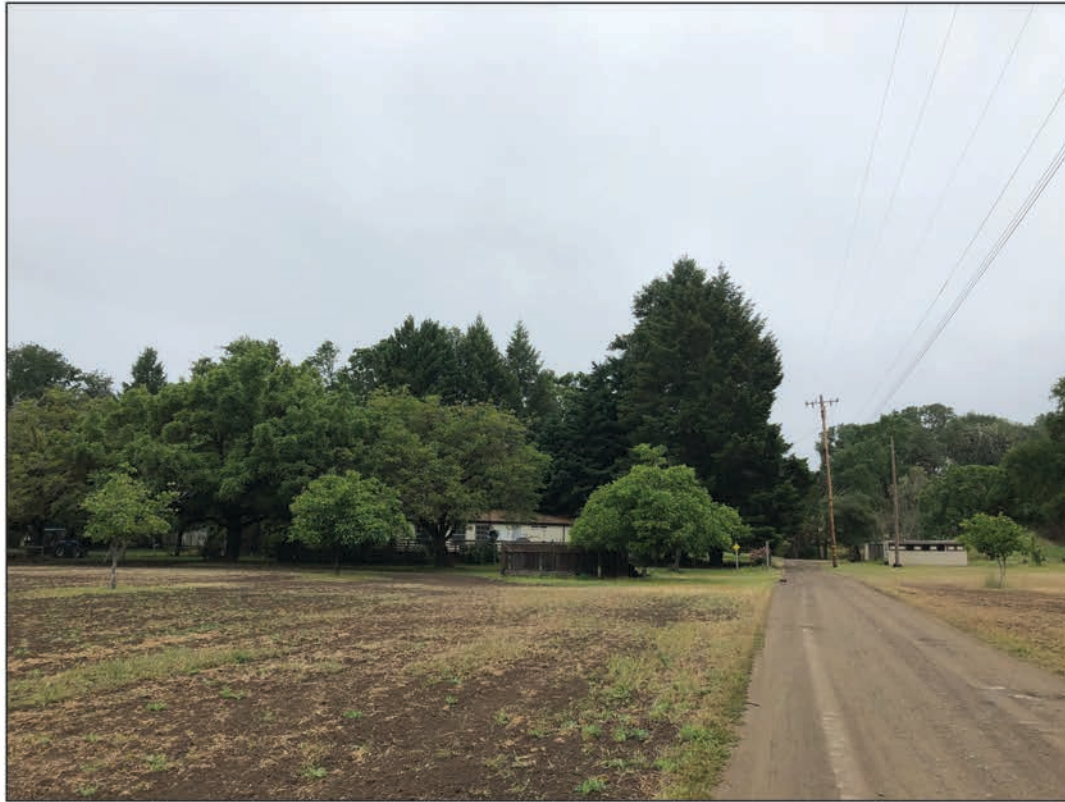
**FIGURE 7: PHOTOGRAPH OF RESIDENCE & ACCESS ROAD**

Access to the parcel is provided to the west off of Hendricks Road, via improved dirt driveway (Figure 7). Onsite structures include several residences, and numerous barns and outbuildings for ranch purposes (Figure 7). There are no existing *Cannabis* cultivation facilities onsite. Several gates provide access at the west and east ends of the access road, and there is also an aboveground power utility easement running east-west through the center of the property (Figure 8).

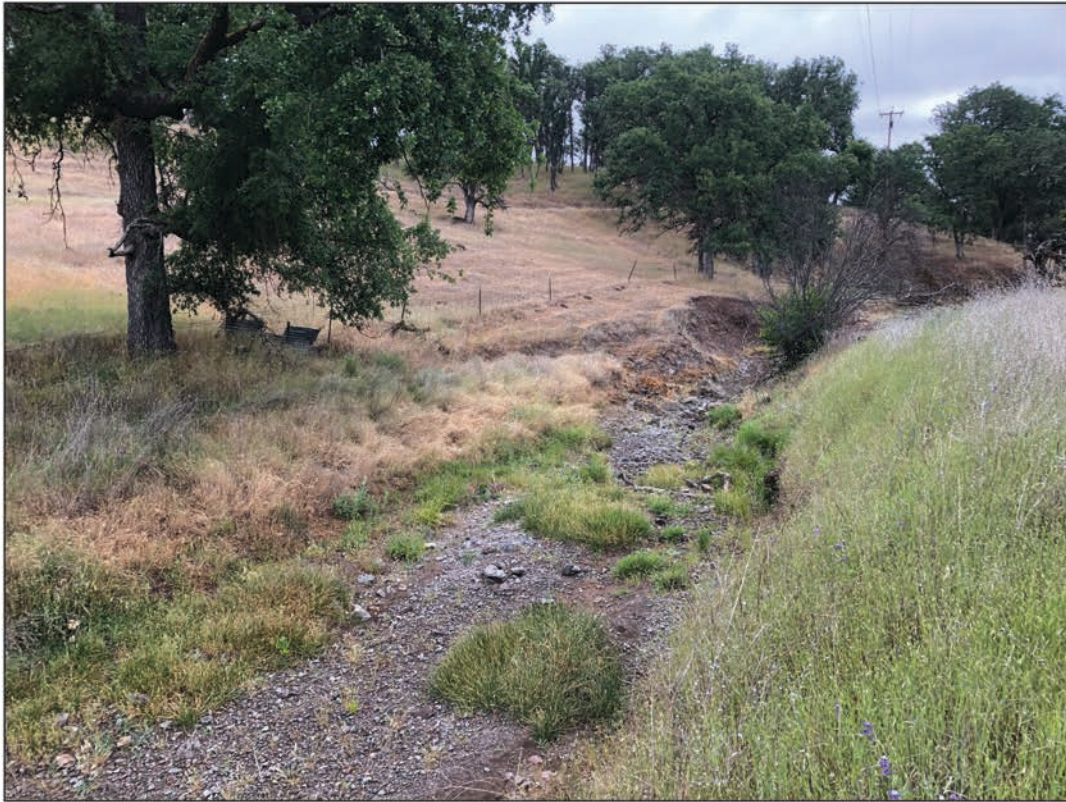
**FIGURE 9: PHOTOGRAPH OF HENDRICKS CREEK (CLASS II)**

The hilly portions of the site are drained by several Class III watercourses, that coalesce into a Class II reach of Hendricks Creek (Figure 9) that flows offsite to the west before turning north and flowing for 1 mile through Scotts Valley before the confluence with Scotts Creek. From the confluence, Scotts Creek flows north for 5 before joining the outflow from the Blue Lakes, and then turning east and south, passing through Tule Lake, before entering Rodman Slough after 10 miles. From the spillway of the Cache Creek Dam, Cache Creek flows east through the inner Coast Ranges for 51 miles before emerging into the Central Valley near Esparto. From there Cache Creek continues east for 28 miles before entering the Yolo Bypass west of the City of Sacramento. From there water flows south into the Sacramento River which flows south for approximately 40 miles before emptying into Suisun Bay and the Pacific Ocean.
