BIOLOGICAL ASSESSMENT

23180 SHADY GROVE ROAD [APN 014-006-16]
LAKE COUNTY, CALIFORNIA

Pinecrest Environmental Consulting
5627 Telegraph Avenue #420
Oakland, California 94609
(510) 881-3039

FEBRUARY 3, 2020

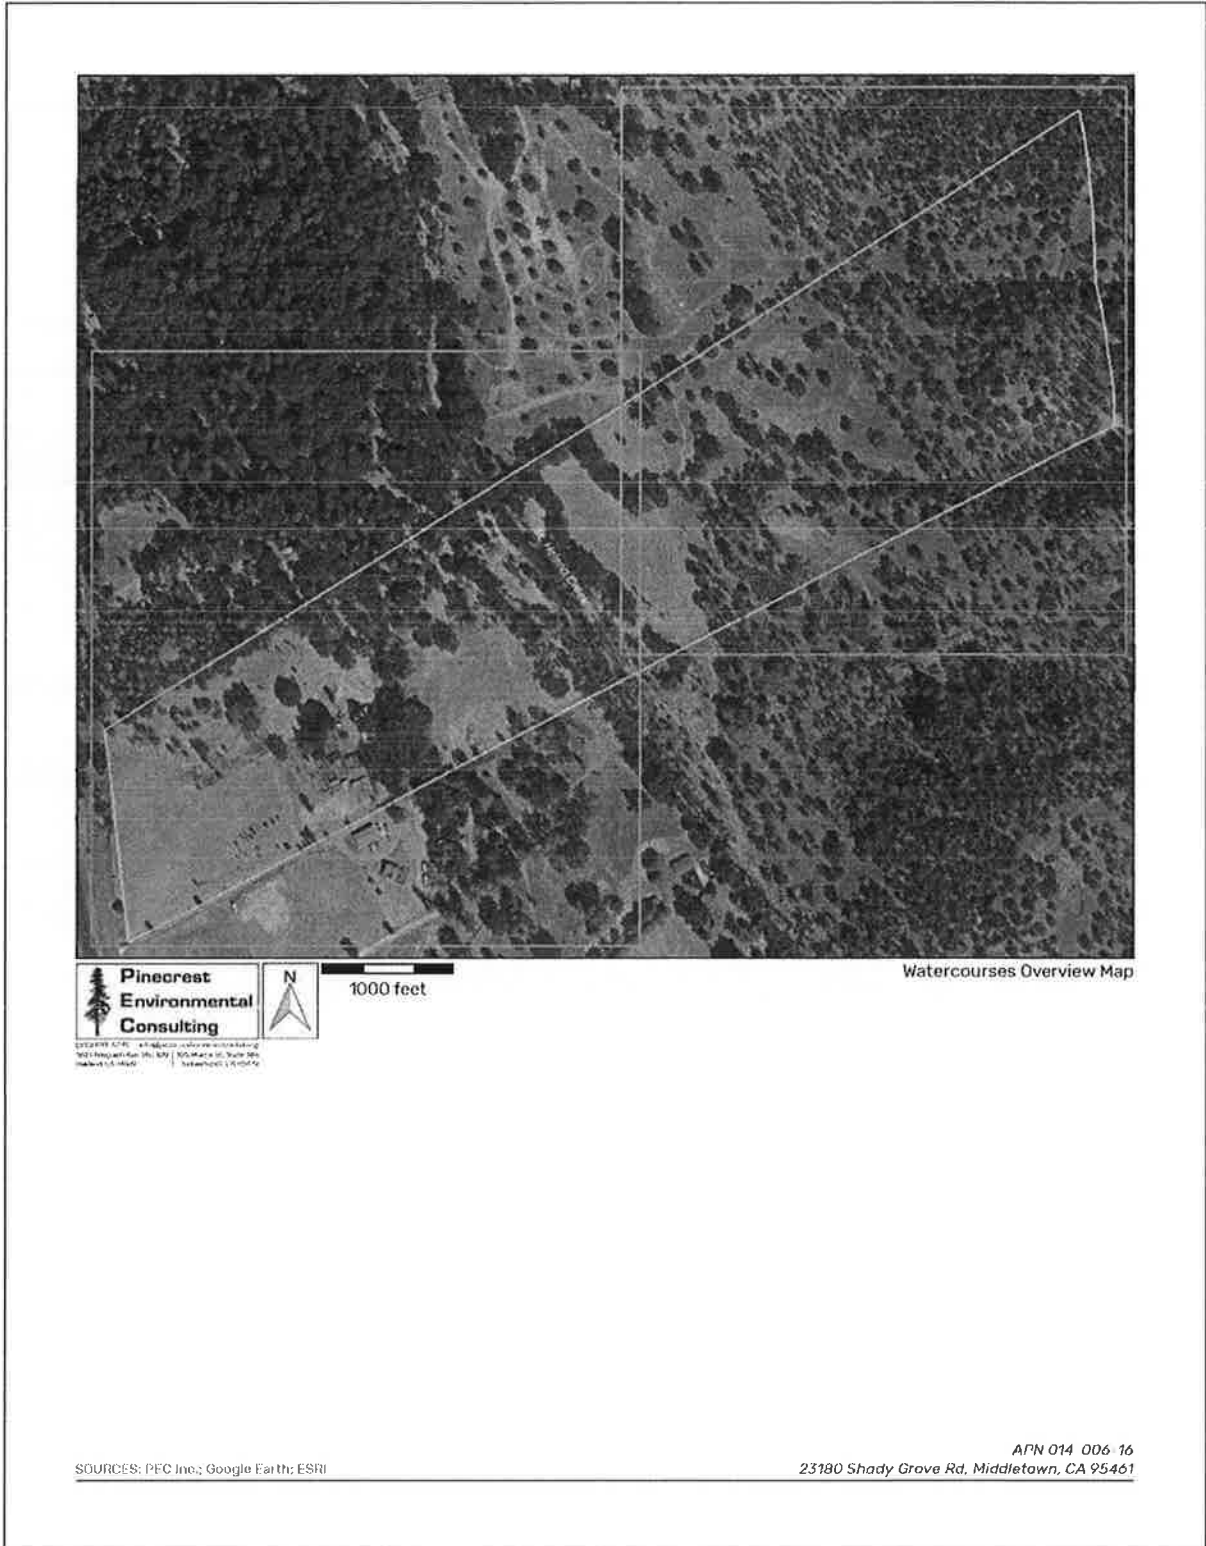
FIGURE 3: WATER FEATURES OVERVIEW

There are several unnamed and one named watercourse on site, as well as several potential wetlands (Figures 3-5). A Class I perennial reach of St. Helena Creek divides the parcel in two, flowing north through the middle of the property (Figure 12). St. Helena Creek is crossed by a metal span bridge (Figure 11) that appears to be stable and with footings that are not obviously eroding. The riparian corridor surrounding St. Helena Creek is well developed and stable. There is also an unnamed seasonal Class II watercourse flowing north through the western portion of the parcel (Figure 13) that is crossed via triple-barrel corrugated metal culvert crossing (Figure 10) that is not obviously in danger of failing but likely does not meet current design specifications for withstanding 100-year floods. This Class II watercourse exits the parcel to the north and joins with St. Helena Creek after flowing offsite for approximately 500 feet. There are also several Class III watercourses onsite. In the western portion of the site, two small stock ponds (Figures 15 & 17) are connected with a vegetated swale (Figure 16) that eventually empty into an unnamed ephemeral Class III watercourse (Figure 14) that flows east for approximately 150 feet before the confluence with the aforementioned unnamed Class II watercourse. There is some wetland vegetation surrounding the ponds and swale but not around the Class III watercourse.

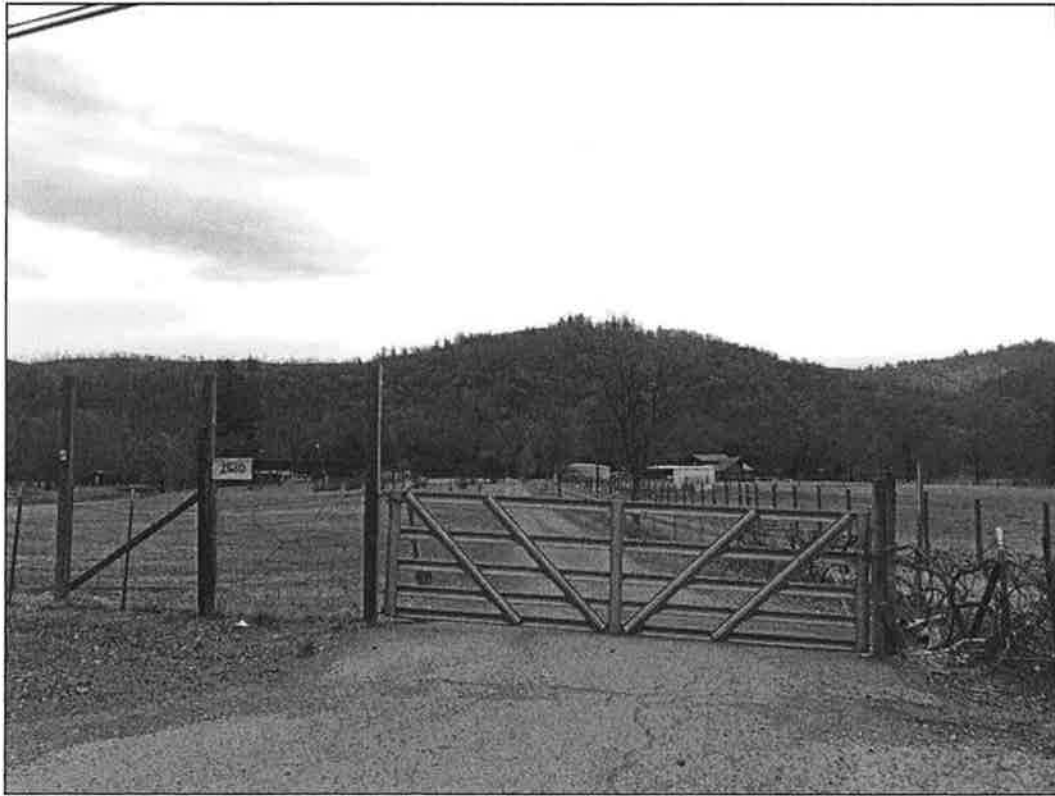
FIGURE 6: PHOTOGRAPH OF ACCESS GATE

Access to the parcel is provided off of Shady Grove Road to the south and is controlled via locking manual entry metal gate (Figure 6). The activity area is located at the end of a graded and graveled unpaved driveway (Figure 7) that is in good condition that travels east from the main gate. This driveway also continues past the main residence and follows the southern property line providing access to the remainder of the parcel (Figures 3-5). There are several existing structures onsite associated with the residence and rural agricultural and animal husbandry activities. There is one residence with garage and multiple outbuildings for chickens, tractors, and other farm related activities (Figure 8). After crossing the triple culvert (Figure 10) you reach a groundwater well and several HDPE water storage tanks (Figure 9) adjacent to a large grassland area that would be suitable for cultivation (Figure 18). Further along the road is a metal span bridge (Figure 11) and another potential cultivation area (Figure 19). Most of the parcel is surrounded by barbed wire fence, and there is a utility pole that transmits electricity via aerial lines off of Shady Grove Road. Other than that there are no other built structures onsite.

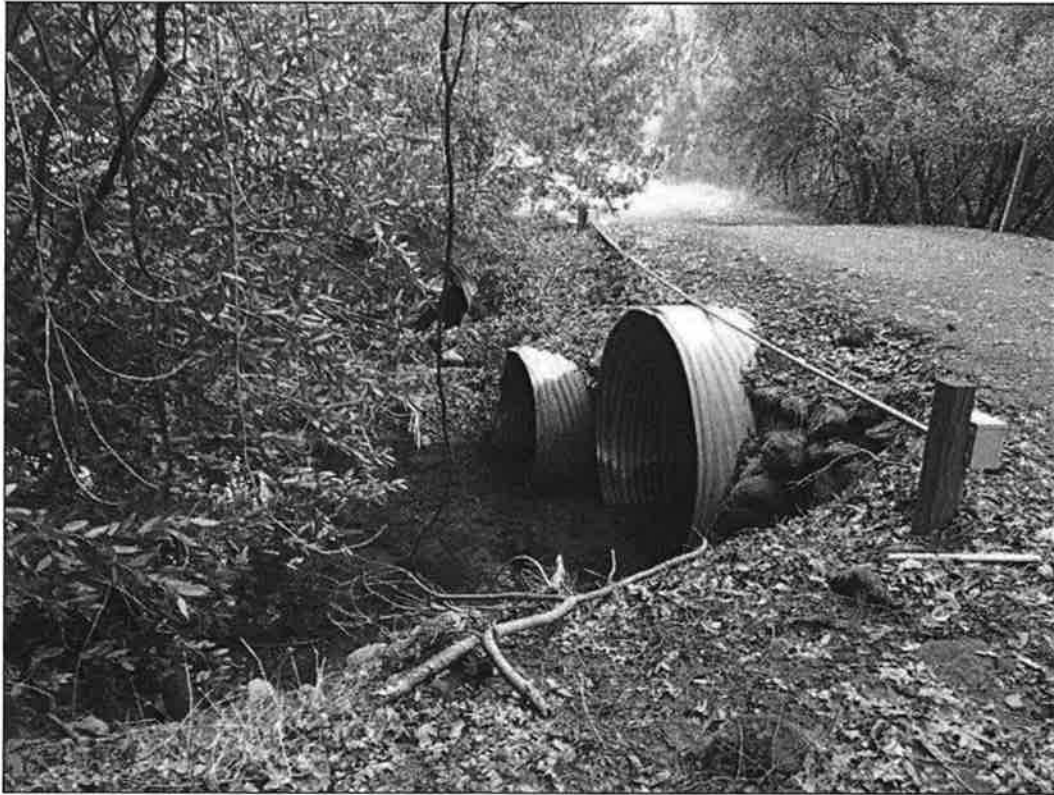
FIGURE 10: PHOTOGRAPH OF TRIPLE CULVERT

No impacts are predicted for sediment discharge to watercourses or wetlands due to the location of proposed cultivation areas outside of required setbacks from watercourses and wetlands. The bridge over the Class I watercourse, and the triple culvert over the Class II watercourse, may need to be registered with CDFW, and consultation with a hydrologist is recommended to determine whether these features are properly sized for a 100-year flood. The driveway is not currently eroding however the outlet to the second pond does not have any protection and is in danger of headcutting and thus some emergency erosion prevention measures should be installed here in consultation with a hydrologist. Native woody species should be planted around the perimeter of these ponds and anywhere else there is bare soil there should be native grasses sown. Additional erosion control measures described in Appendix D should be implemented, and we encourage the use of native vegetation along road cuts and anywhere soil stabilization is required in the future.
