## **PL 25-198 Poverty Flats UP 23-09 IS 23-20**

### **Chapter 4 Grading – Grading Non-Compliance and Mitigation Nullification**

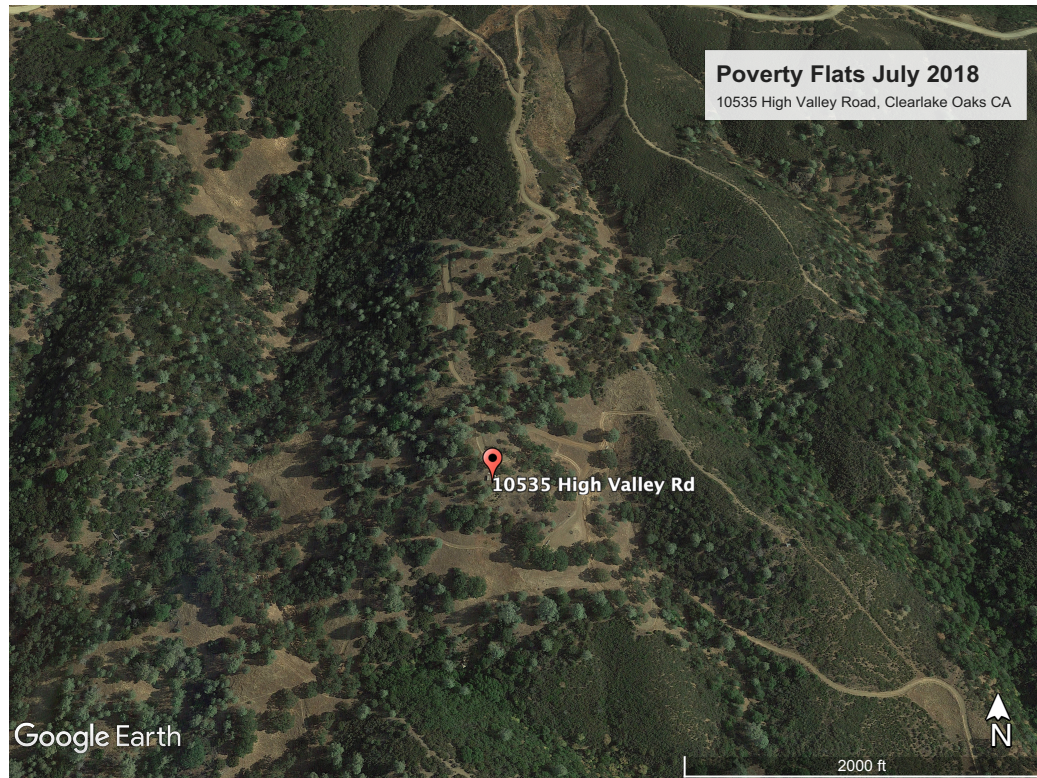
Figure B1: Google Earth Pro image of Poverty Flats property July 2, 2018 showing trees, vegetation, and landscape prior to Mendocino Complex Fire.

- Historical images show the property as a mostly undeveloped, natural landscape with dirt roads and trails until the Mendocino Complex Fire in August 2018 (Figure B1). Post-fire imagery shows substantial remaining vegetation and intact landforms, including native oak trees and chaparral on premises (Figure B2). It also shows the property unchanged since before the fire-- contradicting applicant's claim that part of the cannabis area he wants to develop was used as a firebreak and dozed after the Complex fire, and that there would be no cutting or filling [A4].

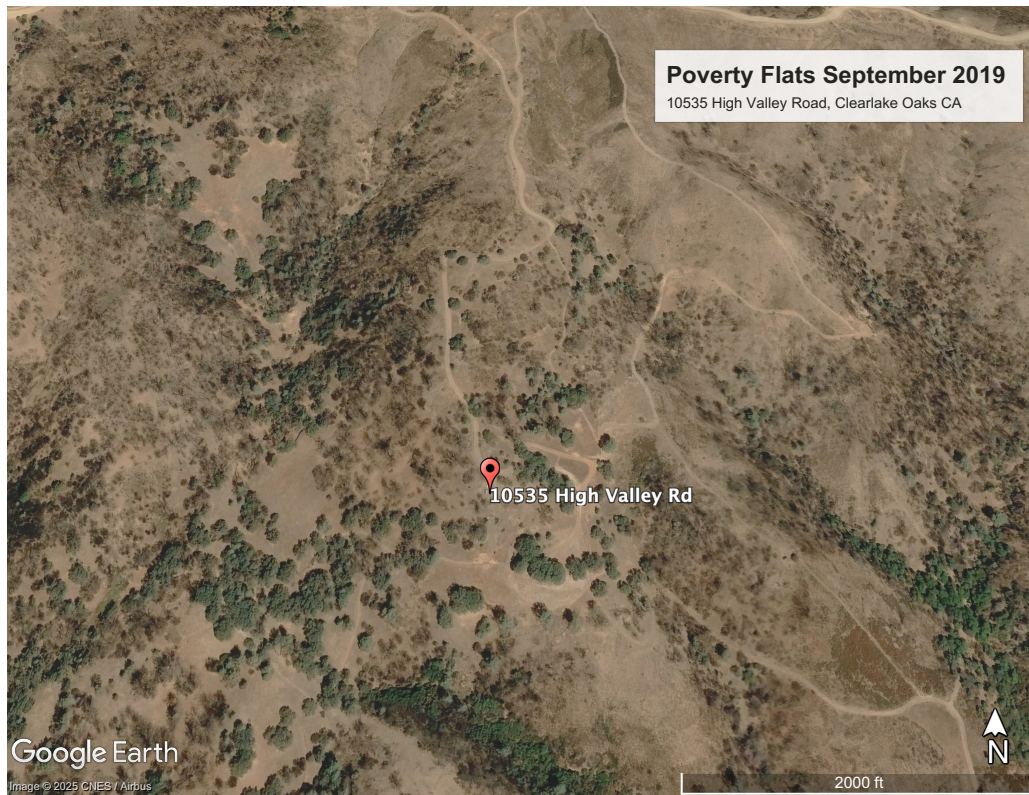
Figure B2: Google Earth Pro image of Poverty Flats Property September 10, 2019 showing trees, vegetation, and landscape after the Mendocino Complex Fire. A5]

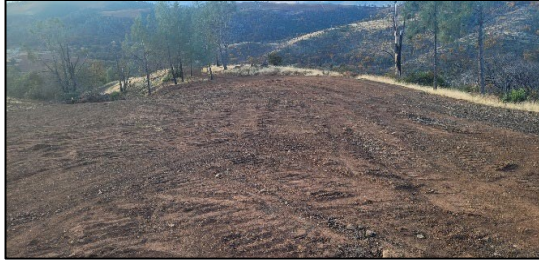
Photograph 1. Overview of planned grow area in Project Area. View south.

Figure B4: Cultural Resources Assessment for the Cannabis Cultivation Operation at 10535 High Valley Road, Clearlake, Lake County, California,” Natural Investigations Company, December 2023.  
(Confidential archaeological data omitted pursuant to Government Code §6254.10 and ARPA §9(a)).

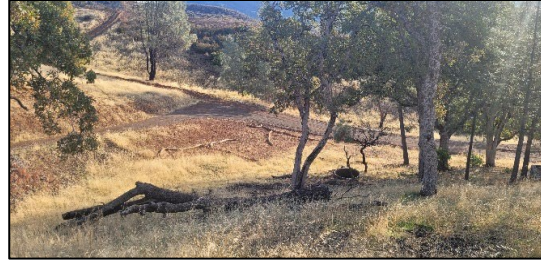
Photograph 2. Overview of planned grow area in Project Area. View east.

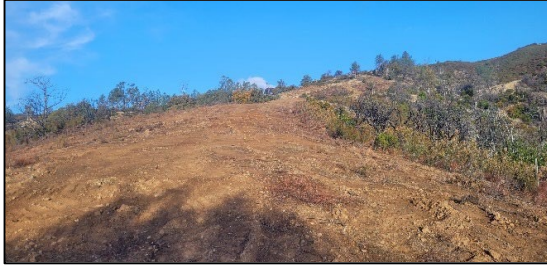
Photograph 3. Overview of planned grow area.

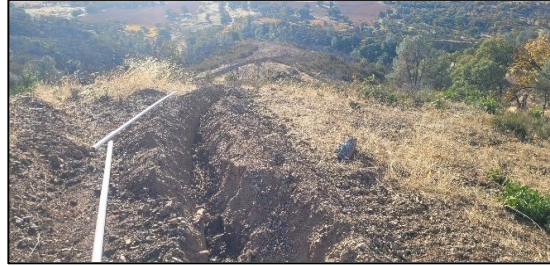
Photograph 4. Overview of waterline trench.

- Cultural/Tribal: Cultural assessment documents heavy machinery grading and ~3-ft trenches; no tribal monitoring agreement was executed [A8]. Tribal Historical Preservation Officer stated in an email July 24, 2025 that he has not been contacted for grading—nullifying TCR-1 mitigation [A20].

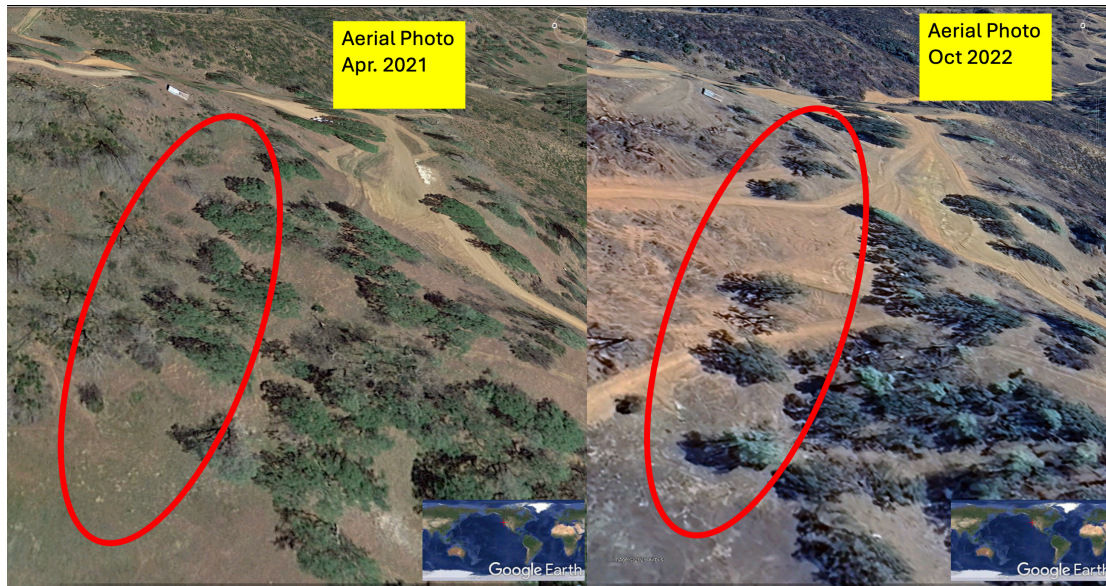
Figure B6: Comparison of aerial images show healthy trees removed and new roads and benching on property.

- Permit GR22-12 “with conditions” (issued 4/14/2022) authorizes “clearing and maintenance of existing firebreak” and “road maintenance/widening to 4290 only in <20% slopes and areas wide enough” with “minimal soil disturbance.” Public Records Request returned no requested copy of permit conditions. [A7]
- Subsequent imagery and cultural documentation show pad cuts, widened benches, and ~3-ft trenches aligned to cultivation areas—characteristic of complex grading, not ministerial maintenance. [A8] (Figures B4, B5, B6)

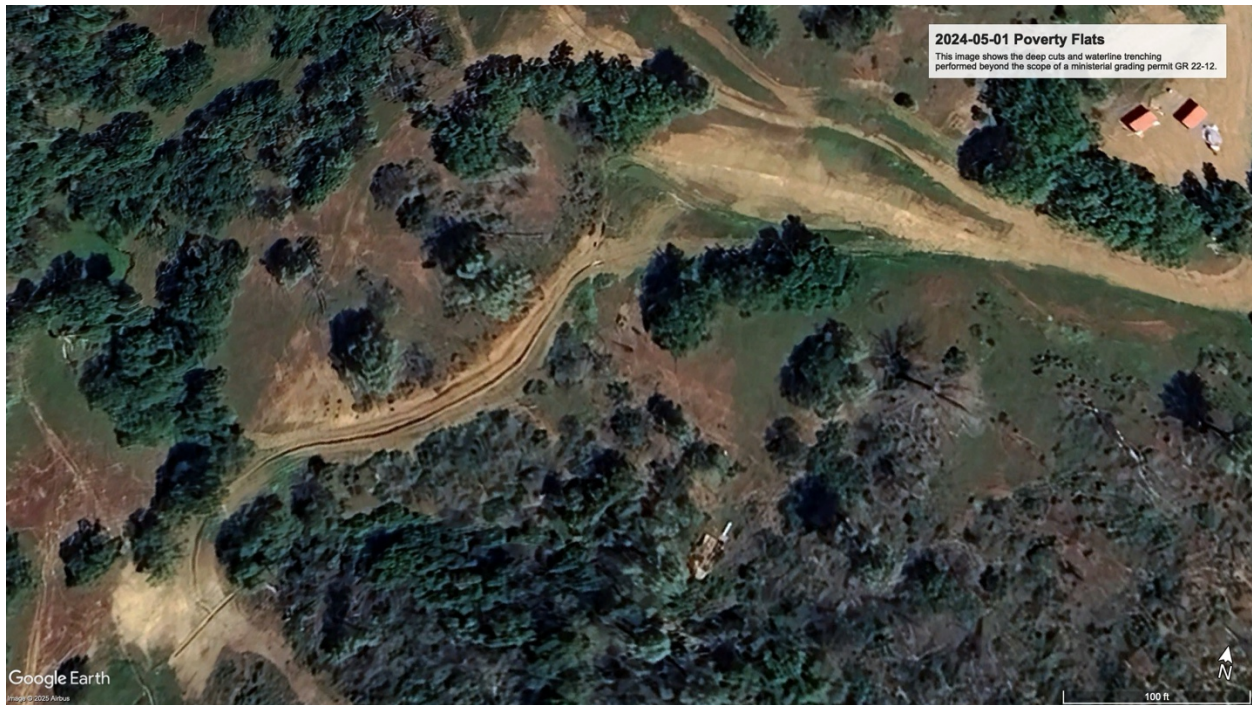
Figure B7: Shows deep trenching for waterlines and deep cuts and bench into steeply sloped land.

- Tribal Historic Preservation Officer met with project applicant on October 30, 2023 but no agreement was reached on contract to oversee ground disturbance activities that could negatively affect cultural resources. [A9]
- The Preliminary Grading Plan, dated October 17, 2023, clearly shows the site layout and cultivation areas for the cannabis project and documents solar arrays, electrical panels, and water line trenching locations. [A10]

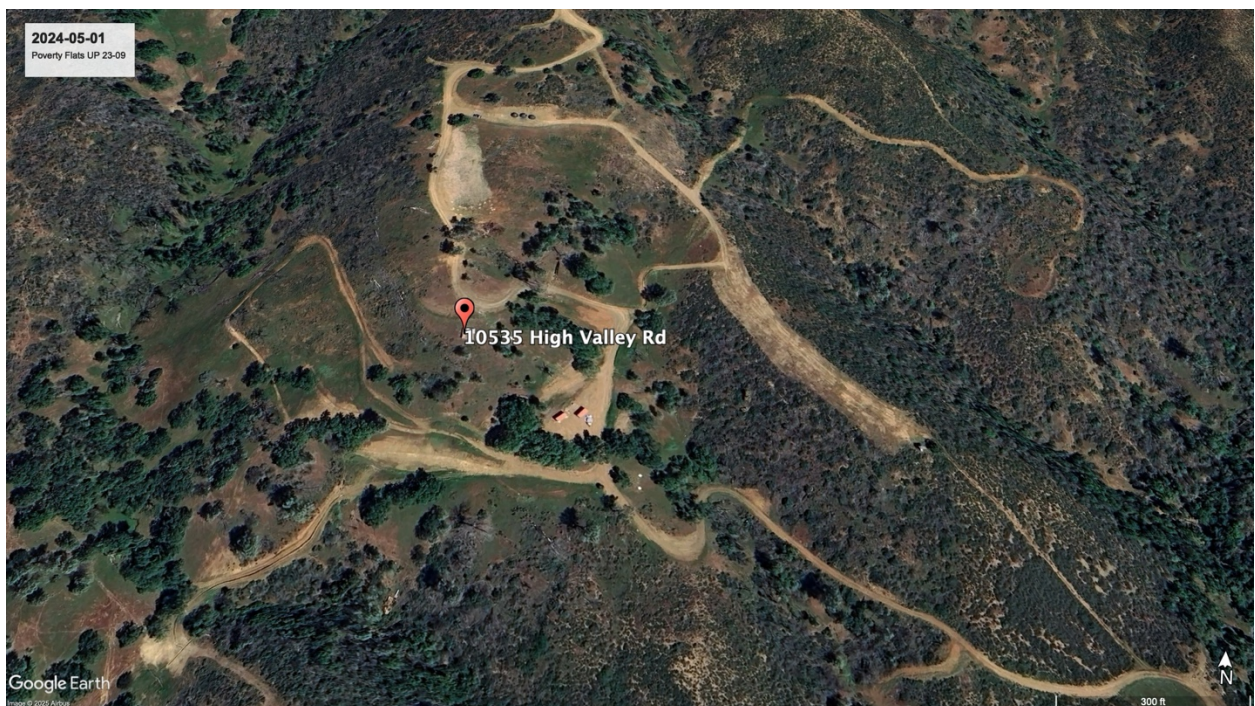
Figure B9: Google Earth Pro image of Poverty Flats Property on May 1, 2024 showing two years of continued grading under ministerial permit GR 22-12 stating “minimal soil disturbance”.

- **Hydrology & Water Quality (Impact WQ-1/WQ-2):** The unpermitted/ministerial-only grading altered on-site drainage patterns, increased runoff rates and volumes, and introduced uncontrolled sediment sources by removing vegetation and compacting pads/roads without the complex-permit BMPs and inspections disclosed in the circulated IS/MND. These changes invalidate the hydrologic assumptions underlying the April IS/MND and constitute significant new information requiring recirculation (Guidelines §15073.5). Absent reinstatement of the complex-permit framework (or equivalent enforceable measures) to size culverts, stabilize outlets, and control erosion, substantial evidence does not support a less-than-significant finding for hydrology and water quality [A23].

- **Erosion Controls:** The Preliminary Grading Plans identified a licensed civil engineer and general contractor responsible for implementation and certifying erosion-control measures. Site disturbance proceeded without their documented participation, inspection logs, or certification, rendering the grading unpermitted under County Code §30-6 and inconsistent with CEQA’s enforceable mitigation framework.
