BIOLOGICAL ASSESSMENT

**16750 HERRINGTON ROAD [APN 013-060-40]
LAKE COUNTY, CALIFORNIA**

PROJECT № LAK013

MARCH 1, 2020

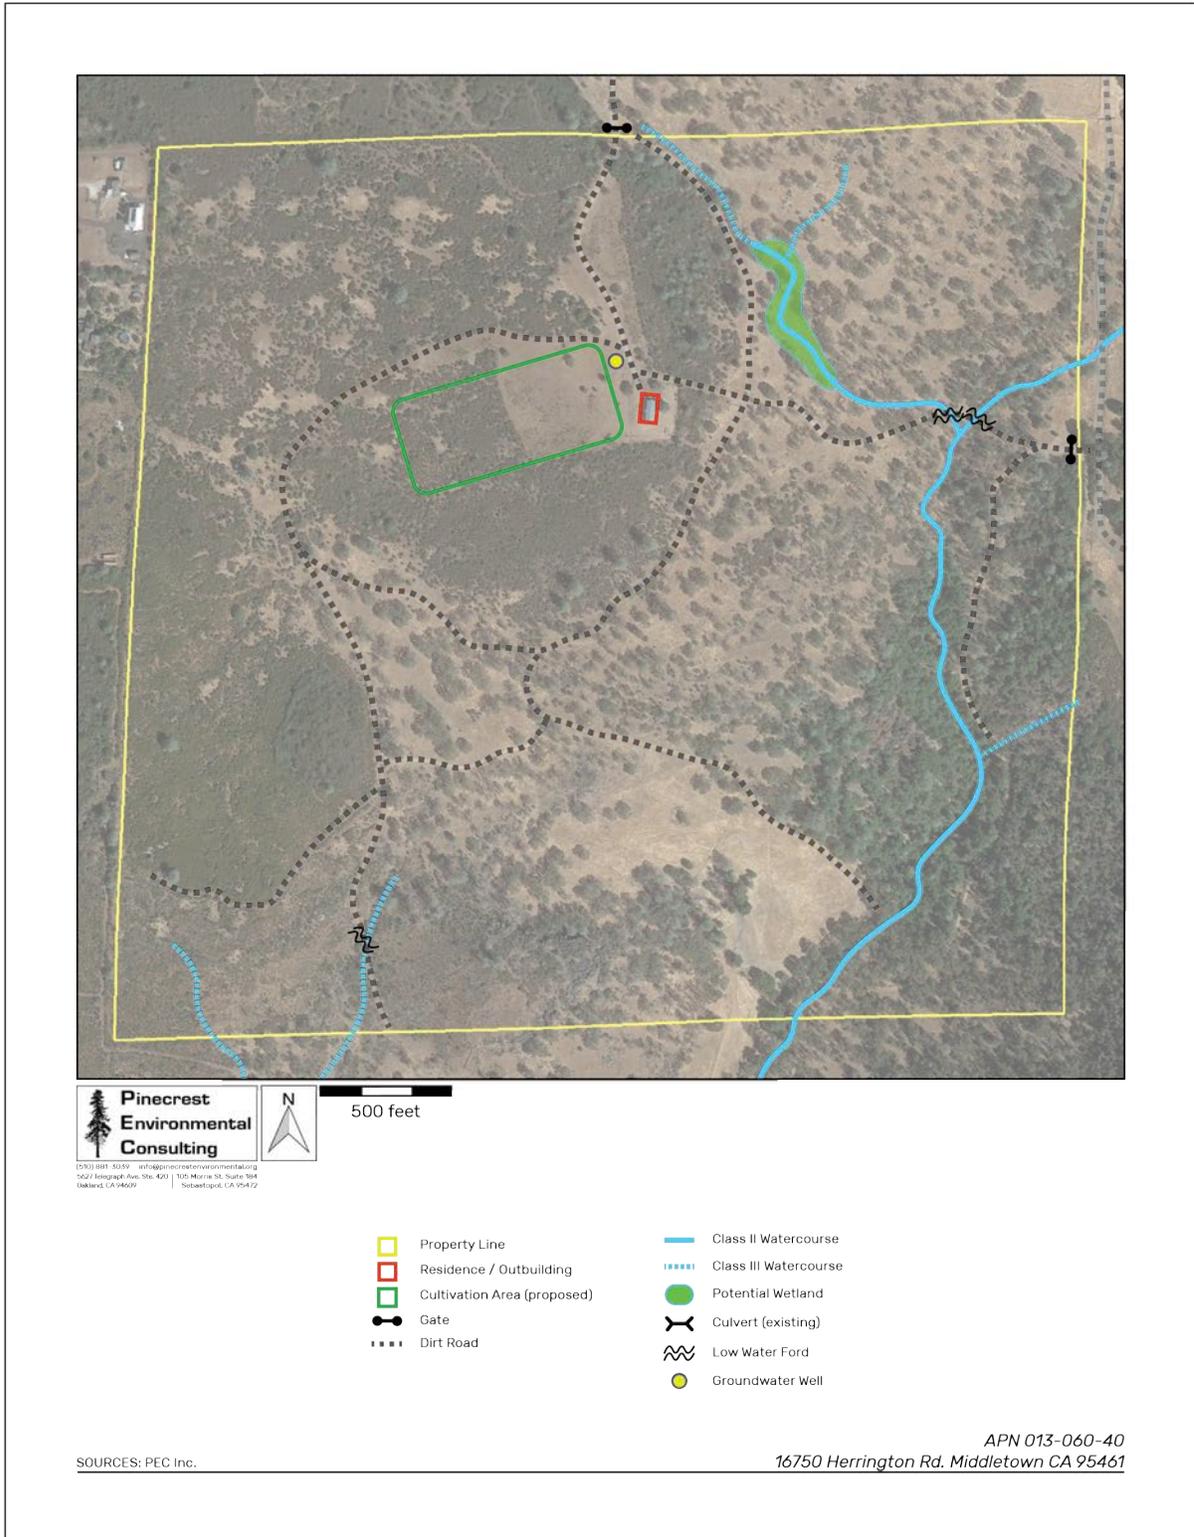
FIGURE 3: WATERCOURSES

There is one main drainage system onsite, a Class II/III network that drains the eastern oak woodland portion of the site (Figure 3). This system has several spurs, and there is one potential wetland associated with this system, along the western branch (Figure 9), although a protocol-level wetland delineation was not performed. There are two low-water ford crossings (Figure 8) on the main stem that appear to be stable and are not required to reach the cultivation area. There are also two small Class III spurs that initiate in the southwest corner of the parcel and extend offsite on the steep chaparral slope.

The parcel consists of a mosaic of oak savannah mixed with *Arctostaphylos* chaparral, with several patches of grassland (Figure 3). Some of the chaparral has been cleared in the past (Figure 10) and this is an ideal location for cultivation since there are few native species coming back in this area for whatever reason. Several watercourses and one potential wetland were identified at the time of the survey, and these are located in the eastern portion of the site in the oak woodland. The property has not been grazed or burned recently and the species composition is reflective of this land use, with large mature oak trees and expanses of unburned manzanita chaparral that extend right up to the eastern border of houses in Hidden Valley Lake. The specific community descriptions below are organized based on the zones that were surveyed, and the floristic results presented in Appendix B. Overall, the north parcel consists of approximately 50% mixed *Quercus-Pinus* woodland, 40% oak and manzanita chaparral, and 10% annual grassland. The grassland has been treated below along with the oak woodland since there is no distinct separation between these community types and the woodland is more savannah-like in places. Chaparral has been treated separately however since much of the chaparral is disturbed and is clearly a different and discrete habitat type and is located in different areas of the parcel than the oak woodland/grassland (Figure 3). There is little differentiating the vegetation surrounding the Class II and III watercourses and potential wetland, although there are a few unique species and these have been described at the end of Section 2.2.2.

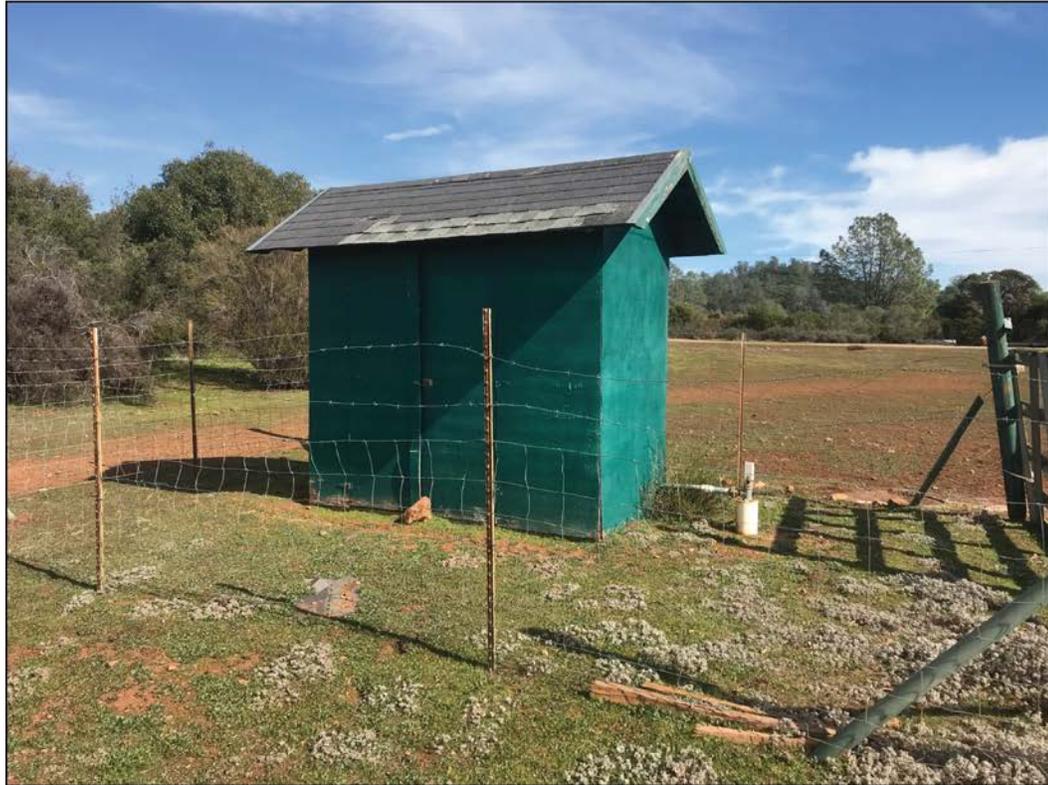
FIGURE 6: PHOTOGRAPH OF GROUNDWATER WELL

There is one existing permanent structure onsite, a two-story barn and residence (Figure 7). There is one groundwater well located to the west of the access road (Figure 6). There is not currently water storage onsite. The potential cultivation area is located on a cleared pad located adjacent to the barn and to the west of the access road in an area of chaparral (Figure 10). Access to the parcel is currently controlled by a locking gate (Figure 5) and the main road/driveway onsite is generally in good condition (Figure 4). The perimeter is not completely fenced but does feature some welded wire wildlife fencing around the barn. Roads and driveways onsite are packed earth and gravel and are generally in good condition although some of the ranch roads providing access to the outlying areas of the property are unimproved (Figure 7). There are no culverts or other water crossings required to reach the proposed cultivation area however there are several water fords in the outlying areas of the property (Figure 8) that do not appear to be eroding or problematic.

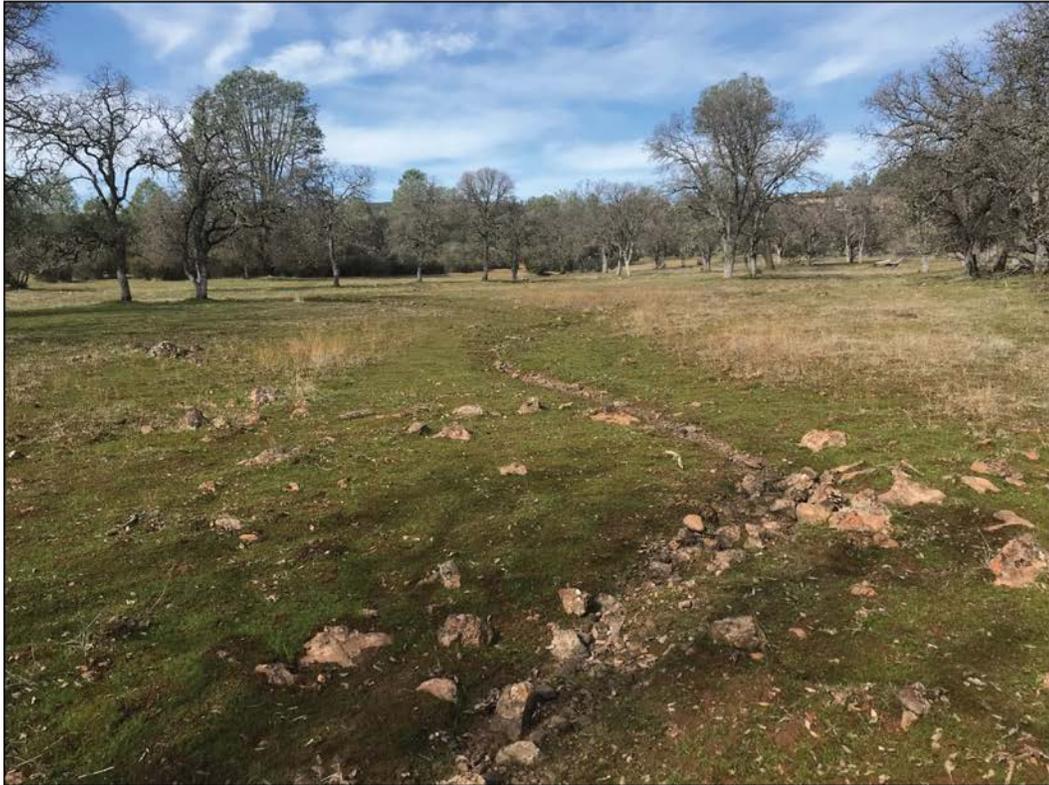
FIGURE 9: PHOTOGRAPH OF POTENTIAL WETLAND

Some wetland and riparian species are evident where the watercourses pass through the grassland and chaparral (Figure 9). While the vegetation is little differentiated there are some unique hydrophytic species including green *Cladophora* algae, toad rush (*Juncus bufonius*), mugwort (*Artemisia douglasiana*), California bedstraw (*Galium californicum*), white meadowfoam (*Limnanthes douglasii*), miner's lettuce (*Claytonia perfoliata*), Himalayan blackberry (*Rubus armeniacus*), and pennyroyal (*Mentha pulegium*).
