BIOLOGICAL RESOURCES ASSESSMENT

**21258 MORGAN VALLEY ROAD [APN 012-069-57]
LAKE COUNTY, CALIFORNIA**

PROJECT № CCC012

MAY 25, 2019

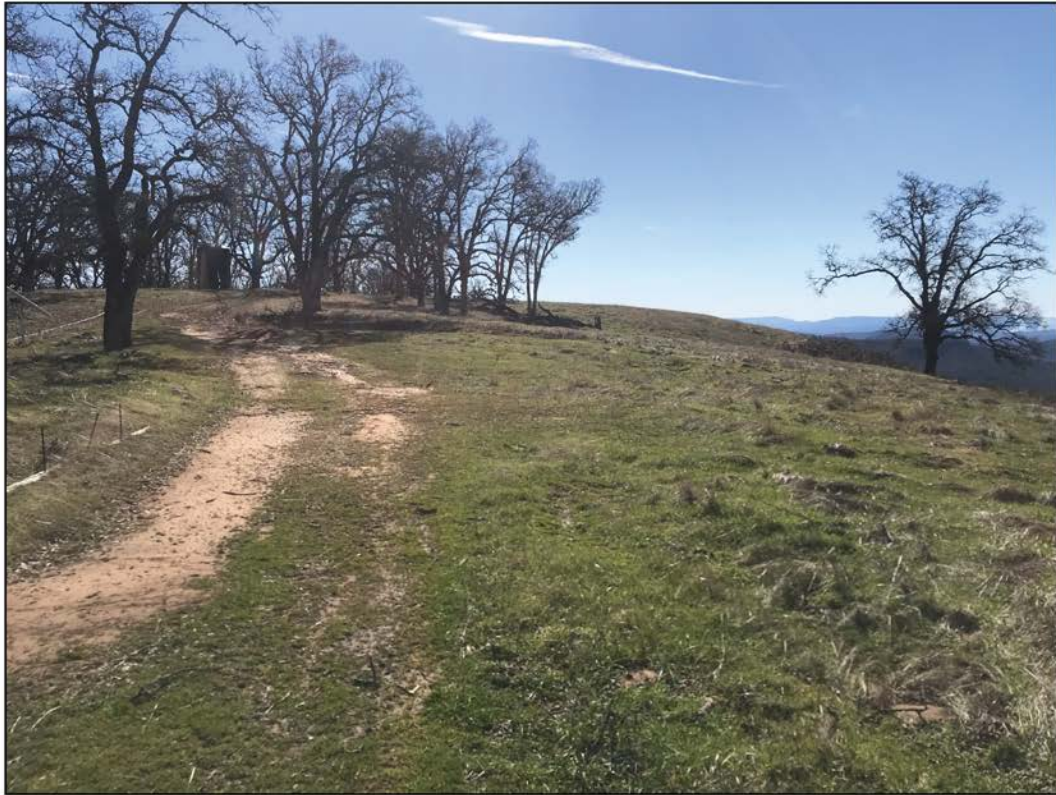
FIGURE 6: PHOTOGRAPH OF ACCESS ROAD

road leading to the project parcel. The main access road on the project parcel shows some erosion due to the heavy rains of 2018-2019 and should be re-graded. The road leading to the project parcel is in poor condition and should be re-graded, although the drainage culverts that are installed are functioning. It is primarily the dirt roadbed that needs water bars or other devices to stop gullyng down the center during high precipitation events. The parcel itself is not surrounded by fencing however there is a locking, manual entry metal gate where the access road branches off of Morgan Valley Road.

The only locations that appear to be in need of erosion control are the road approaches to the cultivation area, which suffered some gulying after the rains of 2018-2019. Despite this, there is low chance of these erosional features discharging sediment to waters of the State because of the grassland and chaparral vegetation between the roadway and channels is intact. These erosional features on the roadbed should be remediated using closely spaced water bars or other method to prevent linear flow down the center of the roadbed prior to next year's rains so that the vegetation can continue to function to trap sediment and new erosional features do not form. Additional erosion control measures described in Appendix D should be implemented, and we encourage the use of native vegetation along road cuts and anywhere soil stabilization is required in the future.

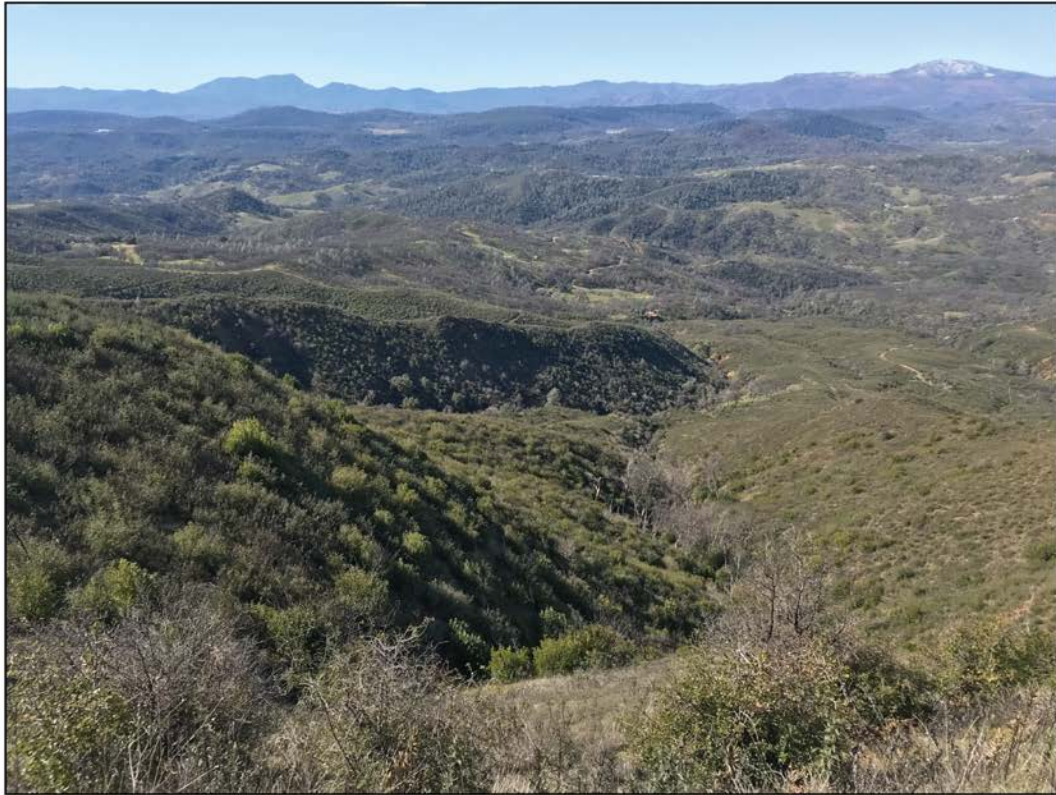
FIGURE 7: PHOTOGRAPH OF CLASS III WATERCOURSE

Streams and watercourses onsite were classified according to the three-tier method used by the California Department of Forestry & Fire Protection (CALFIRE 2017) and included as a reference in Appendix E. Jurisdictional streamcourses are mapped in Figure 3. According to these criteria, there are roughly seven unnamed seasonal Class III watercourses onsite that flow northeast and southwest off of the main ridge top. The classification begins about 200-300 feet from through the top of the ridge, and measurements should be made to verify that the gardens do not infringe on the setbacks for any of the mapped drainages in case erosion increases and the distance from the mapped drainage (Figure 3) to the cultivation area becomes smaller. These channels flow through deeply incised and densely vegetated draws, with heavy chaparral preventing examination of the bed. It is expected that these watercourses are ephemeral, do not exhibit aquatic invertebrate life, and only flow during high rain events.

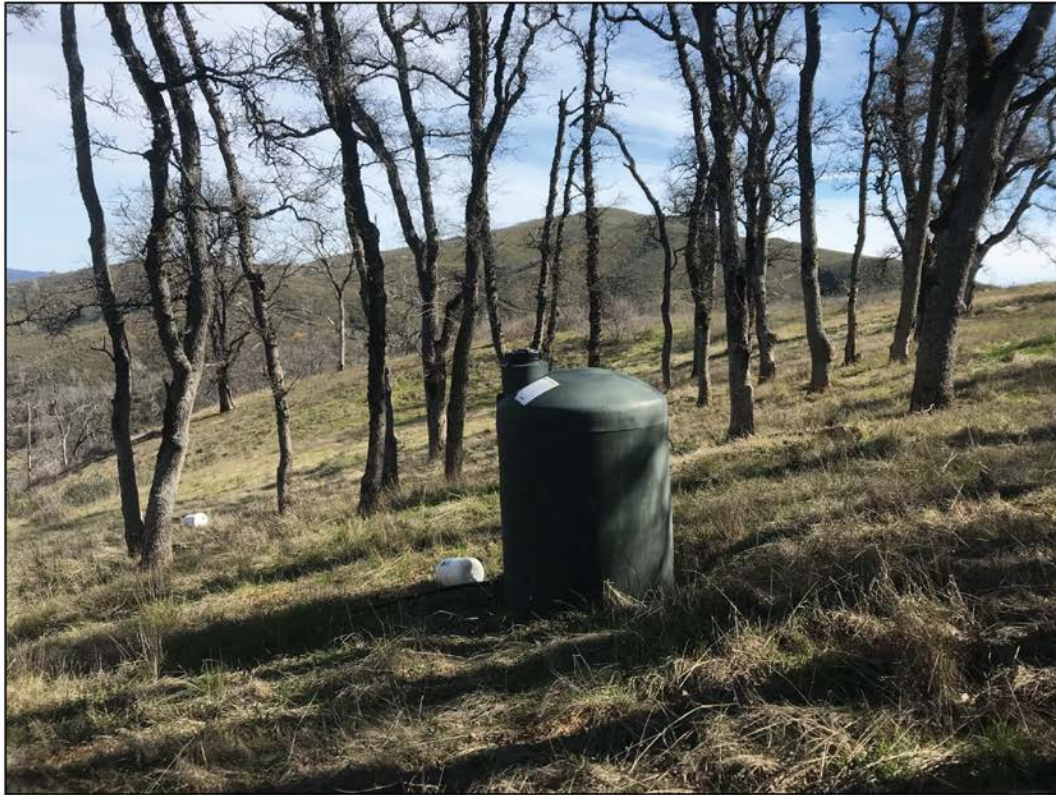
FIGURE 8: PHOTOGRAPH OF WATER STORAGE A

There are no existing structures onsite including residential dwellings or storage sheds/outbuildings. There is one solar powered well (Figure 14) located at the top of the ridge, and several HDPE storage tanks for water including one 5,000 gal and one approximately 1,500 gal unit (Figures 8 & 9). There are no culverts or water crossings on the project parcel, although there are several crossings on the
