# **BIOLOGICAL RESOURCES ASSESSMENT**

**1850 OGULIN CANYON ROAD [APN 010-053-03]  
LAKE COUNTY, CALIFORNIA**

PROJECT No LAK003

AUGUST 4, 2019

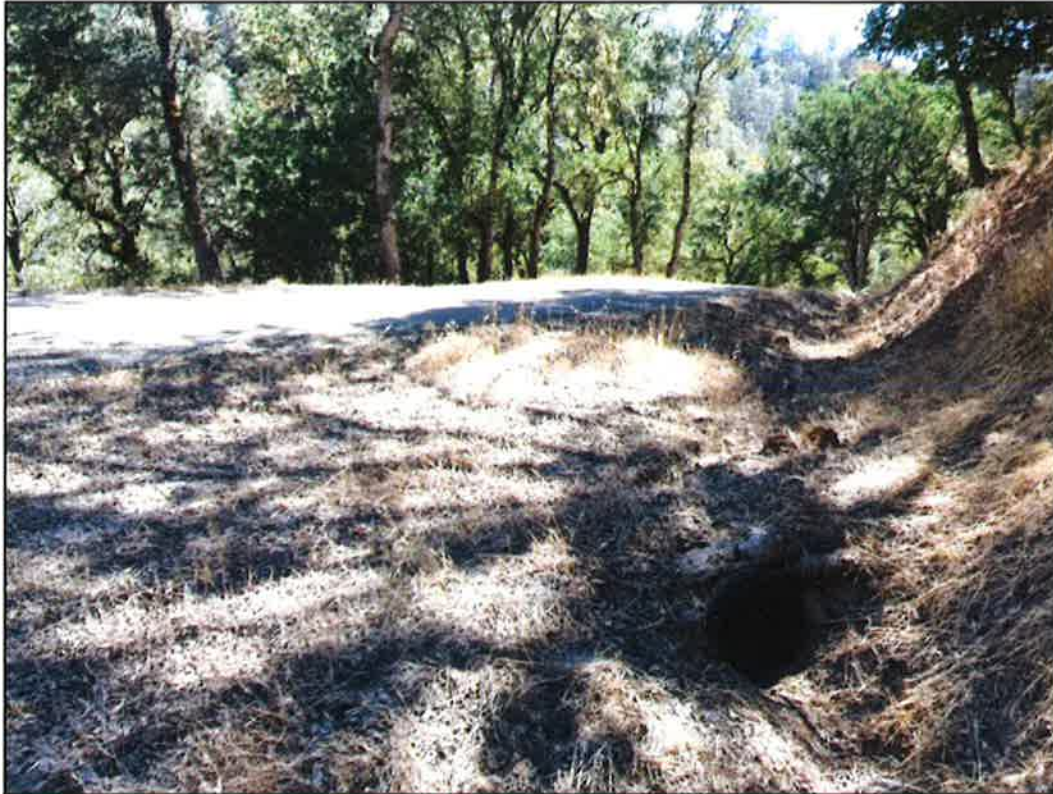
**FIGURE 7: PHOTOGRAPH OF CULVERT 'A'**

Streams and watercourses onsite were classified according to the three-tier method used by the California Department of Forestry & Fire Protection (CALFIRE 2017) and included as a reference in Appendix E. Jurisdictional streamcourses are mapped in Figure 3. According to these criteria, there are two unnamed ephemeral Class II watercourses onsite. The main drainage flows through Blackeye Canyon and drains a series of smaller Class III watercourses that flow through the steep chaparral hillslope in the south portion of the parcel (Figure 11). A second Class II drainage flows north in the far northeast portion of the parcel. Several drainage culverts exist onsite (Figure 3). The culvert designated "A" is a corrugated metal approximately 12" diameter pipe with rock protection (Figure 7), and the culvert designated "B" is an approximately 10" HDPE ditch relief culvert also with rock protection (Figure 8). The culverts appear to be functioning properly and do not exhibit evidence of overtopping.

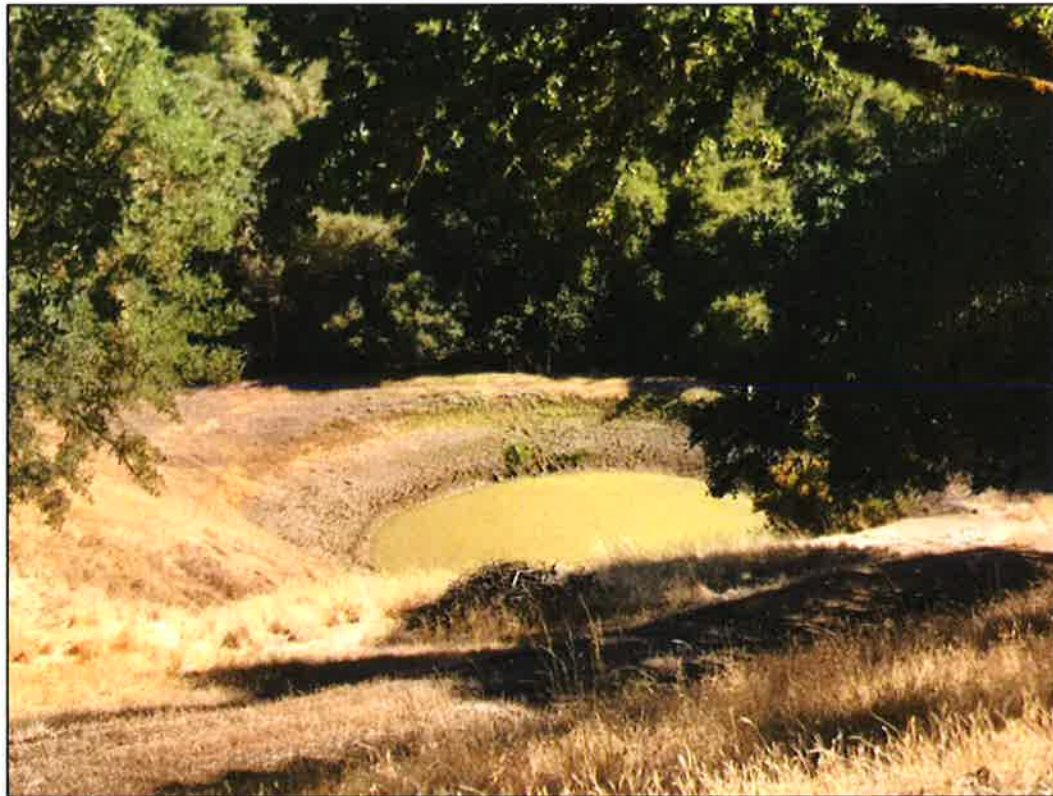
**FIGURE 13: PHOTOGRAPH OF STOCK POND**

The stock pond is not likely to be jurisdictional due to the lack of a defined inlet stream, and it is our recommendation that this feature is not an instream reservoir and instead collects subsurface flow locally. The stock pond is small and measures approximately 0.06 surface acres and has an outlet composed of a 24" corrugated metal pipe that is buried into the earthen fill dam and spills out into an area of intact vegetation to the west. There was no streamchannel observed associated with the outfall and it does not appear that the outfall spills every year.
