# **BIOLOGICAL ASSESSMENT**

**16750 HERRINGTON ROAD [APN 013-060-40]  
LAKE COUNTY, CALIFORNIA**

PROJECT № LAK013

MARCH 1, 2020

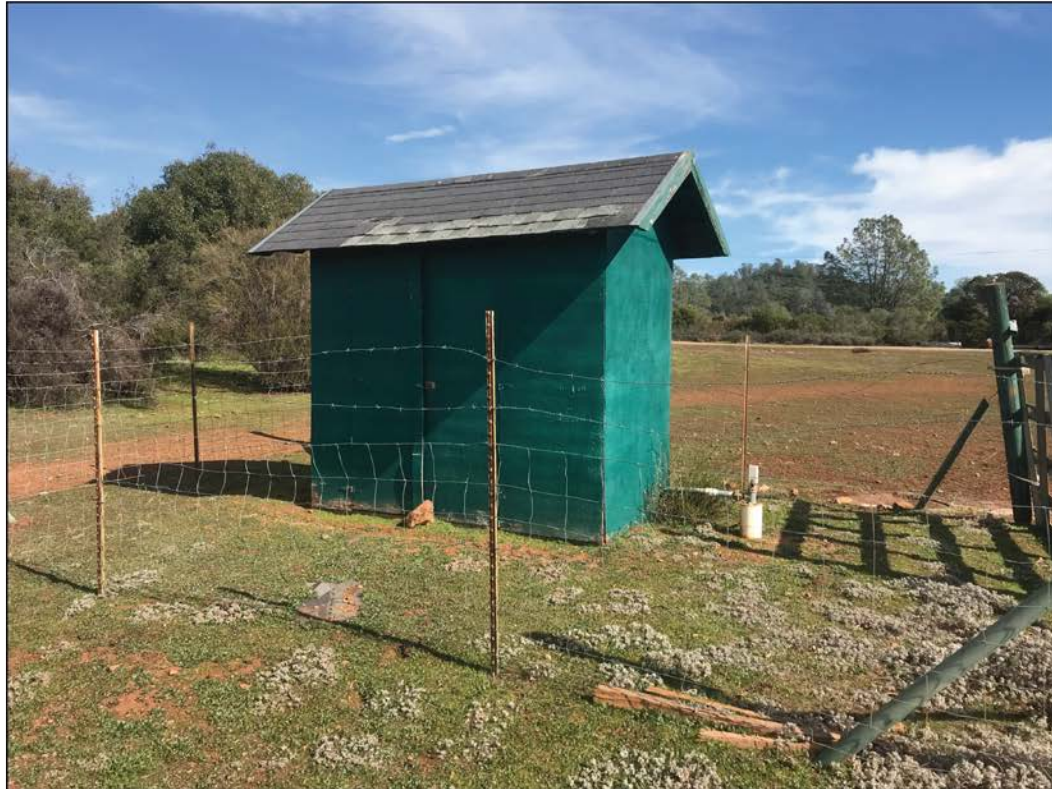
**FIGURE 6: PHOTOGRAPH OF GROUNDWATER WELL**

There is one existing permanent structure onsite, a two-story barn and residence (Figure 7). There is one groundwater well located to the west of the access road (Figure 6). There is not currently water storage onsite. The potential cultivation area is located on a cleared pad located adjacent to the barn and to the west of the access road in an area of chaparral (Figure 10). Access to the parcel is currently controlled by a locking gate (Figure 5) and the main road/driveway onsite is generally in good condition (Figure 4). The perimeter is not completely fenced but does feature some welded wire wildlife fencing around the barn. Roads and driveways onsite are packed earth and gravel and are generally in good condition although some of the ranch roads providing access to the outlying areas of the property are unimproved (Figure 7). There are no culverts or other water crossings required to reach the proposed cultivation area however there are several water fords in the outlying areas of the property (Figure 8) that do not appear to be eroding or problematic.

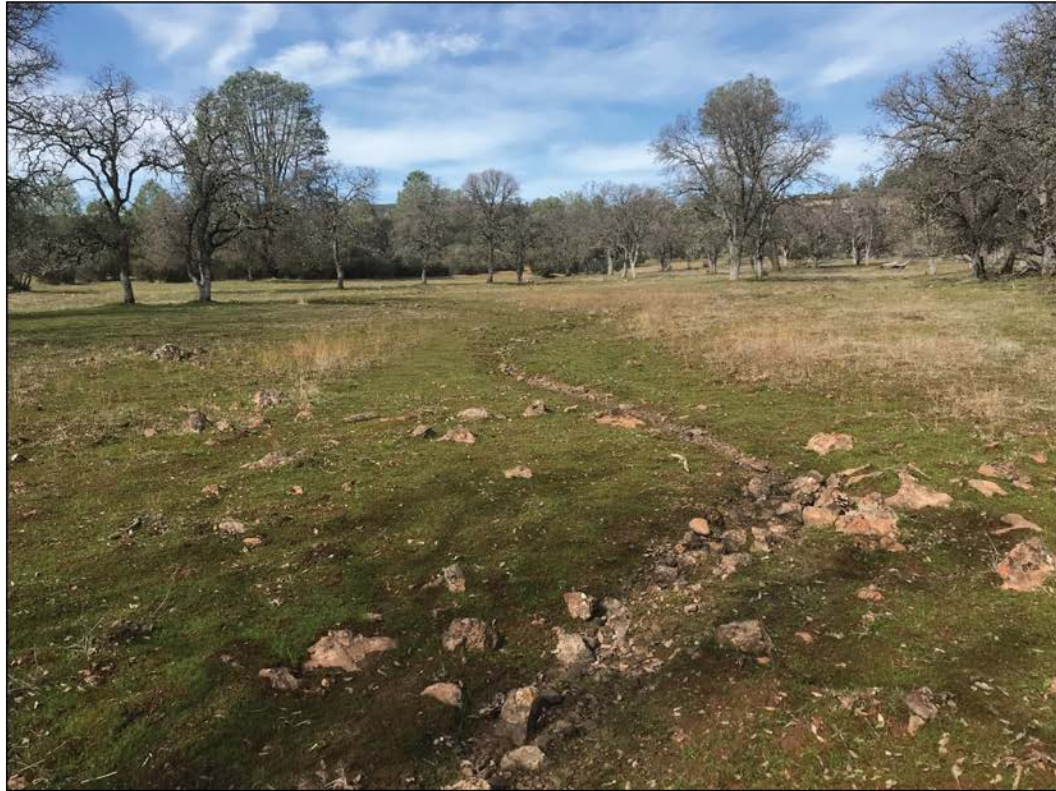
**FIGURE 9: PHOTOGRAPH OF POTENTIAL WETLAND**

Some wetland and riparian species are evident where the watercourses pass through the grassland and chaparral (Figure 9). While the vegetation is little differentiated there are some unique hydrophytic species including green *Cladophora* algae, toad rush (*Juncus bufonius*), mugwort (*Artemisia douglasiana*), California bedstraw (*Galium californicum*), white meadowfoam (*Limnanthes douglasii*), miner's lettuce (*Claytonia perfoliata*), Himalayan blackberry (*Rubus armeniacus*), and pennyroyal (*Mentha pulegium*).
