## **PL 25-198 Poverty Flats UP 23-09 IS 23-20**

### **Chapter 4 Grading – Grading Non-Compliance and Mitigation Nullification**

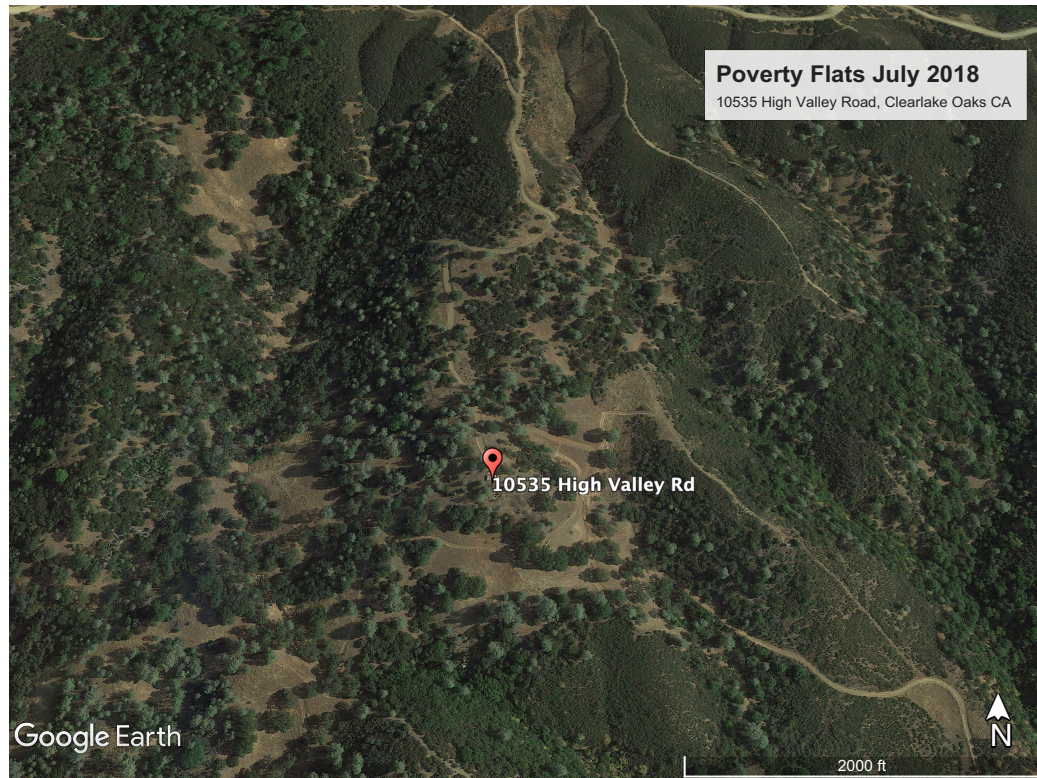
- Historical images show the property as a mostly undeveloped, natural landscape with dirt roads and trails until the Mendocino Complex Fire in August 2018 (Figure B1). Post-fire imagery shows substantial remaining vegetation and intact landforms, including native oak trees and chaparral on premises (Figure B2). It also shows the property unchanged since before the fire-- contradicting applicant's claim that part of the cannabis area he wants to develop was used as a firebreak and dozed after the Complex fire, and that there would be no cutting or filling [A4].

Figure B1: Google Earth Pro image of Poverty Flats property July 2, 2018 showing trees, vegetation, and landscape prior to Mendocino Complex Fire.

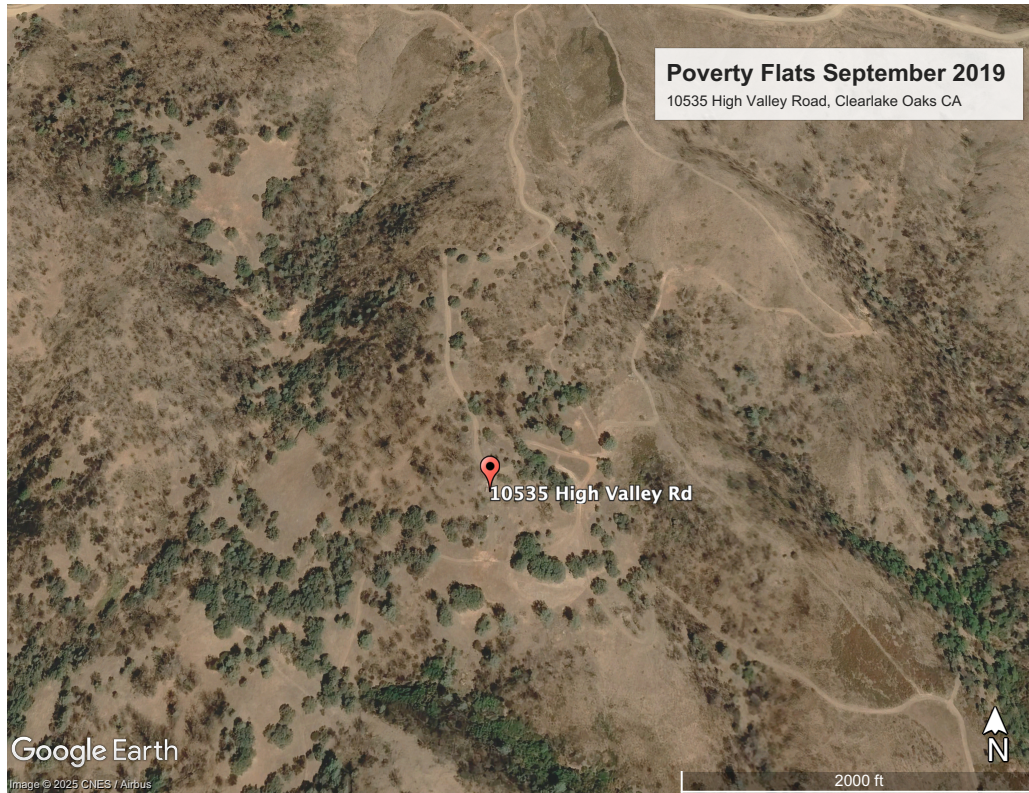
Figure B2: Google Earth Pro image of Poverty Flats Property September 10, 2019 showing trees, vegetation, and landscape after the Mendocino Complex Fire. A5]

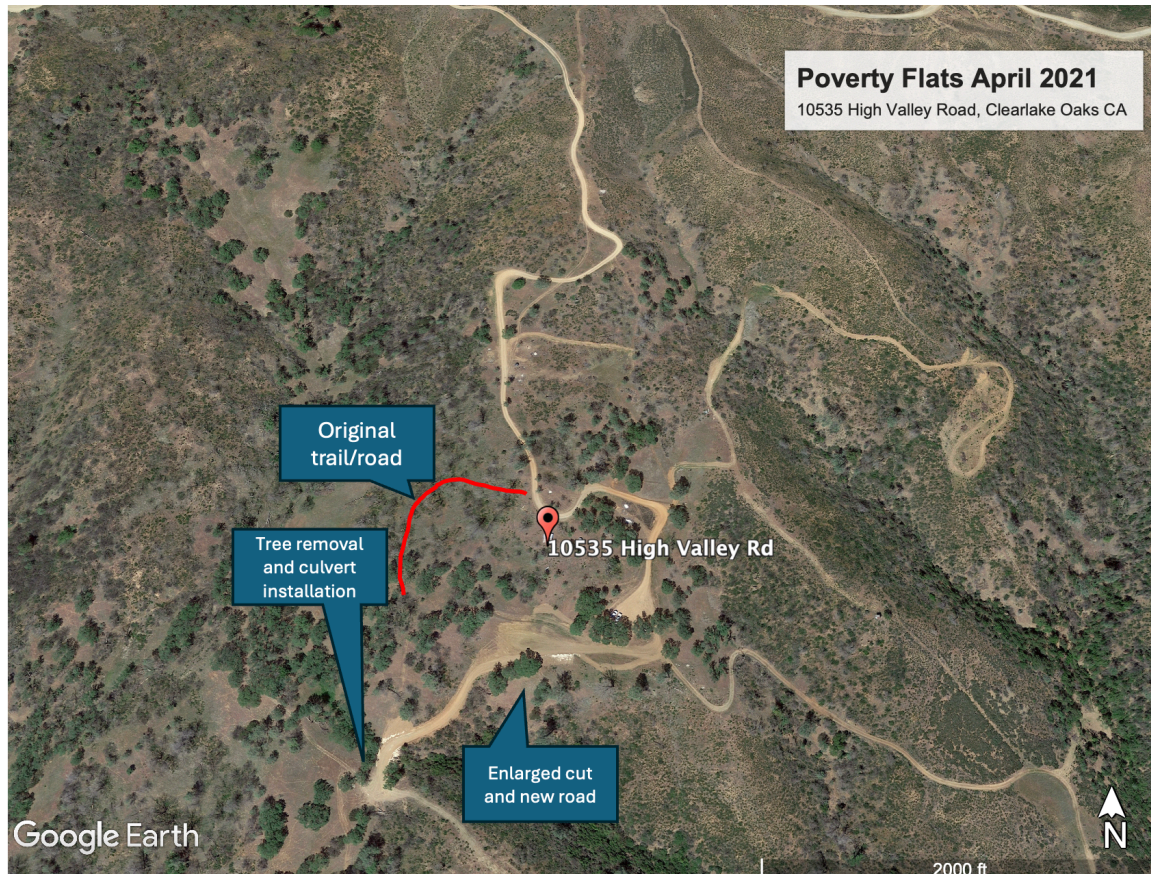
- By April 18, 2021 aeriels (Figure B3) capture grading/trenching and tree removal before any grading permit or Lake Streambed Alteration Agreement, while applicant emails seek permits for canopy preparation after grading began [A5]. Applicant stated that CalFire graded fire breaks after the Mendocino Complex Fire but aerial imagery shows otherwise [A6].

Figure B3: Google Earth Pro image of Poverty Flats Property April 18, 2021 showing original trail/road (red line), removal for culvert installation area, and enlarged cuts and new road.

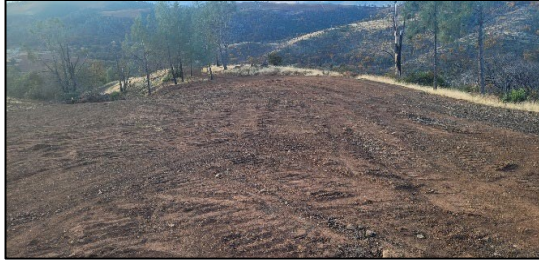
Photograph 1. Overview of planned grow area in Project Area. View south.

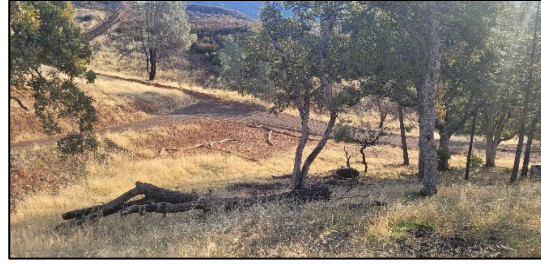
Photograph 2. Overview of planned grow area in Project Area. View east.

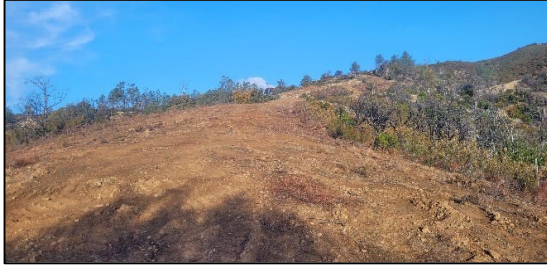
Photograph 3. Overview of planned grow area.

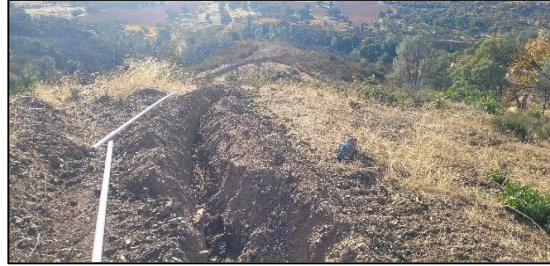
Photograph 4. Overview of waterline trench.

- Cultural/Tribal: Cultural assessment documents heavy machinery grading and ~3-ft trenches; no tribal monitoring agreement was executed [A8]. Tribal Historical Preservation Officer stated in an email July 24, 2025 that he has not been contacted for grading—nullifying TCR-1 mitigation [A20].

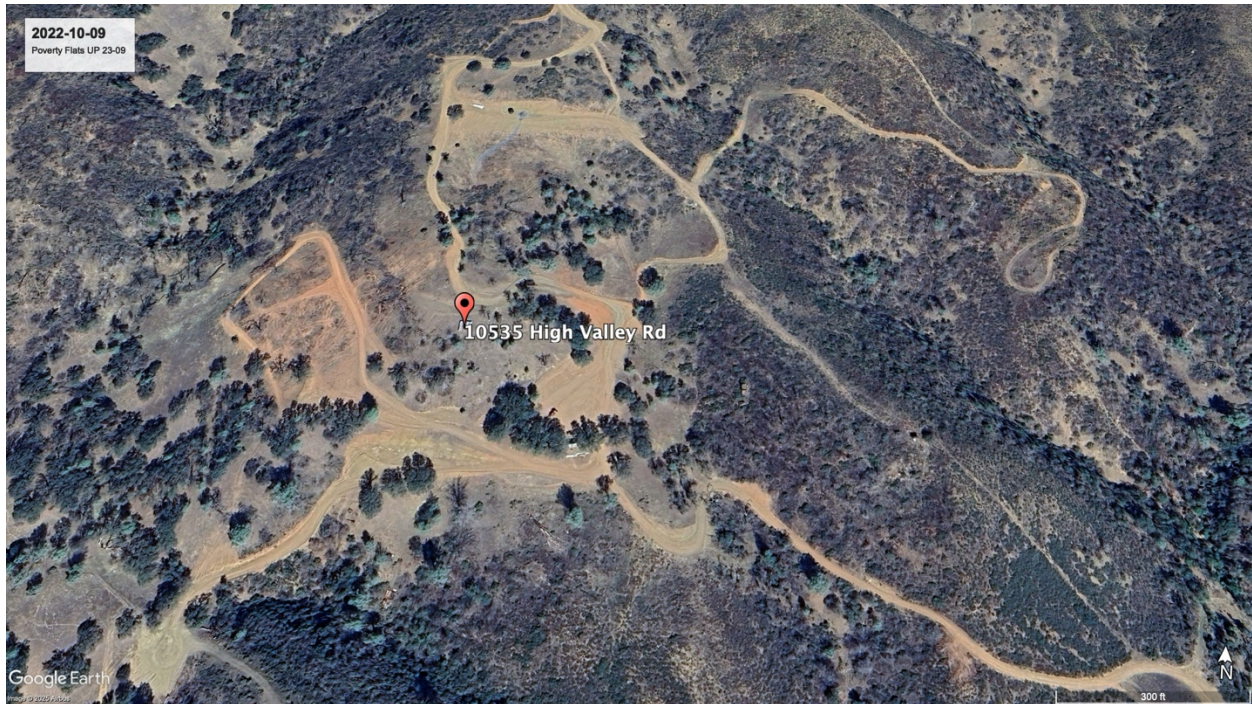
- Permit GR22-12 “with conditions” (issued 4/14/2022) authorizes “clearing and maintenance of existing firebreak” and “road maintenance/widening to 4290 only in <20% slopes and areas wide enough” with “minimal soil disturbance.” Public Records Request returned no requested copy of permit conditions. [A7]
- Subsequent imagery and cultural documentation show pad cuts, widened benches, and ~3-ft trenches aligned to cultivation areas—characteristic of complex grading, not ministerial maintenance. [A8] (Figures B4, B5, B6)

Figure B5: Google Earth Pro image of Poverty Flats Property on October 9, 2022 showing six months of continued grading under ministerial permit GR 22-12.

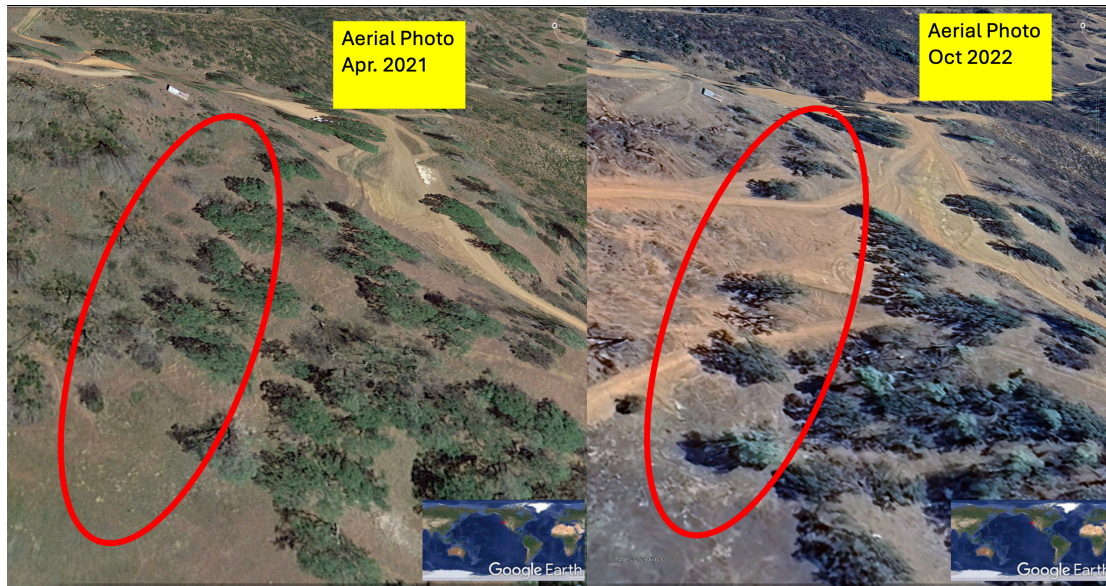
Figure B6: Comparison of aerial images show healthy trees removed and new roads and benching on property.

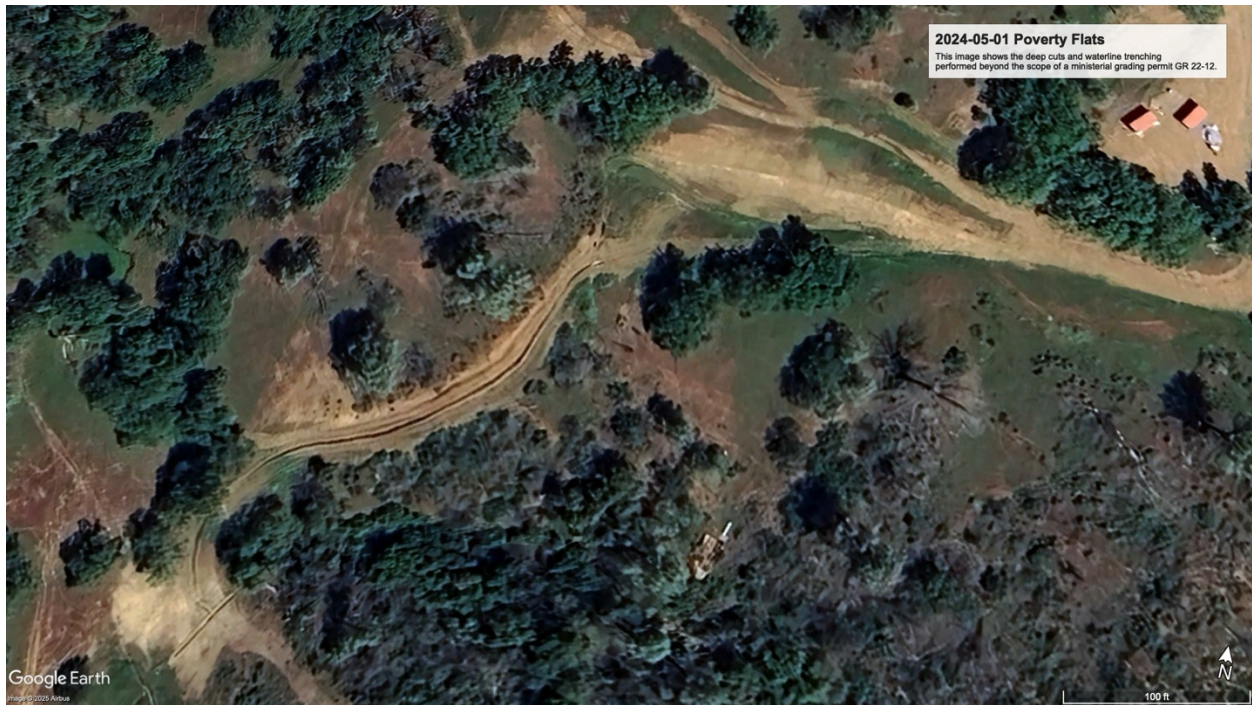
Figure B7: Shows deep trenching for waterlines and deep cuts and bench into steeply sloped land.

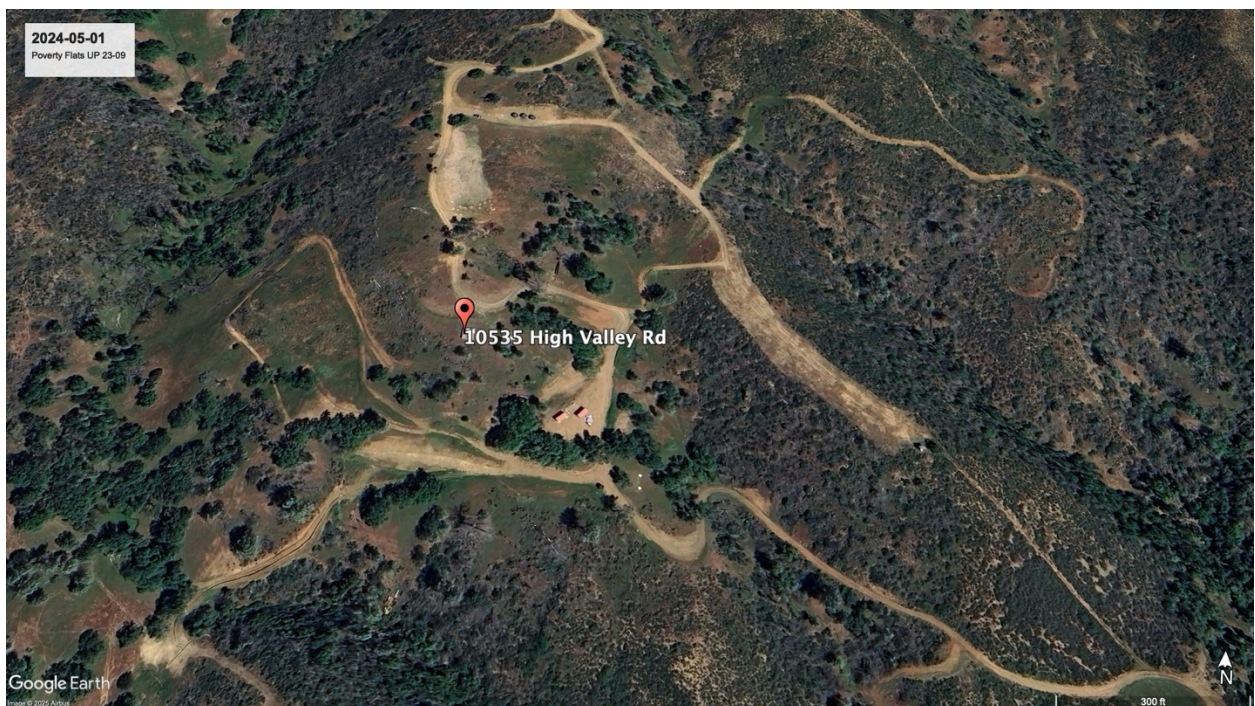
- **Hydrology & Water Quality (Impact WQ-1/WQ-2):** The unpermitted/ministerial-only grading altered on-site drainage patterns, increased runoff rates and volumes, and introduced uncontrolled sediment sources by removing vegetation and compacting pads/roads without the complex-permit BMPs and inspections disclosed in the circulated IS/MND. These changes invalidate the hydrologic assumptions underlying the April IS/MND and constitute significant new information requiring recirculation (Guidelines §15073.5). Absent reinstatement of the complex-permit framework (or equivalent enforceable measures) to size culverts, stabilize outlets, and control erosion, substantial evidence does not support a less-than-significant finding for hydrology and water quality [A23].

Figure B9: Google Earth Pro image of Poverty Flats Property on May 1, 2024 showing two years of continued grading under ministerial permit GR 22-12 stating “minimal soil disturbance”.
