CALIFORNIA ENVIRONMENTAL QUALITY ACT ENVIRONMENTAL CHECKLIST FORM INITIAL STUDY IS 20-96

1. **Project Title:** AT&T Cell Tower

2. **Permit Number:** Use Permit, UP 20-80

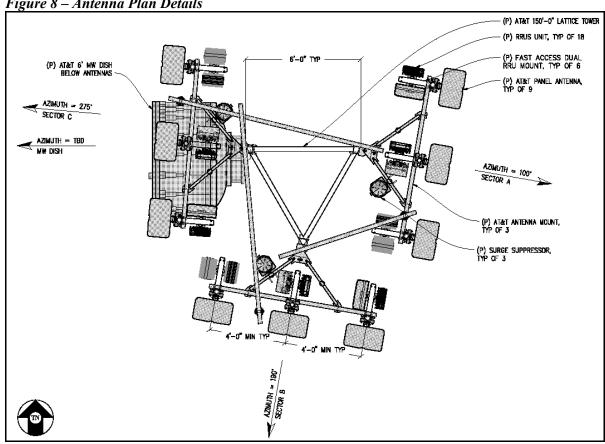
Figure 9 – Tower Elevations

Construction of the 150' tall cell tower is anticipated to take between six and eight weeks. Staging of equipment will occur to northeast of the proposed site location.
